Asset #02534(Other Special Recurring)

Us-79/Sec16/L11.51 over Alligator Bayou

Location: .7 Mi South Of Brickeys

Team Lead: Drew Melton Inspection Date: 11/21/2023

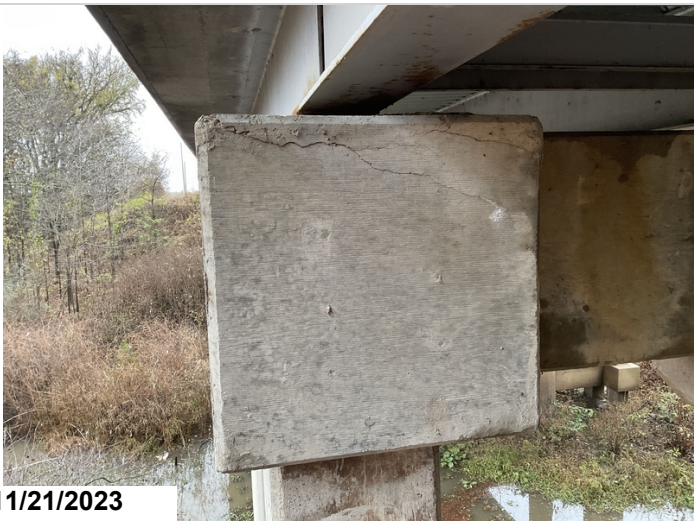
Bent #5 cap ahead face right side extension is cracked and delaminated for 2' at top.

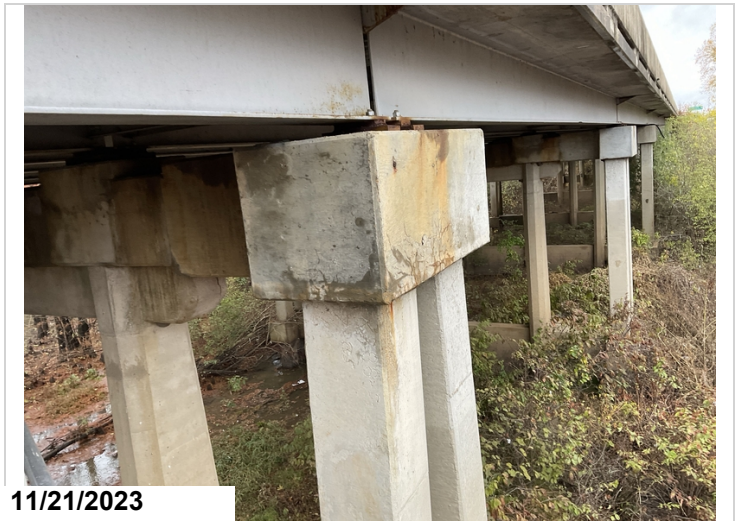
Bent #5 cap right end has 1' of cracking and delaminated area at end of old cap and new cap.

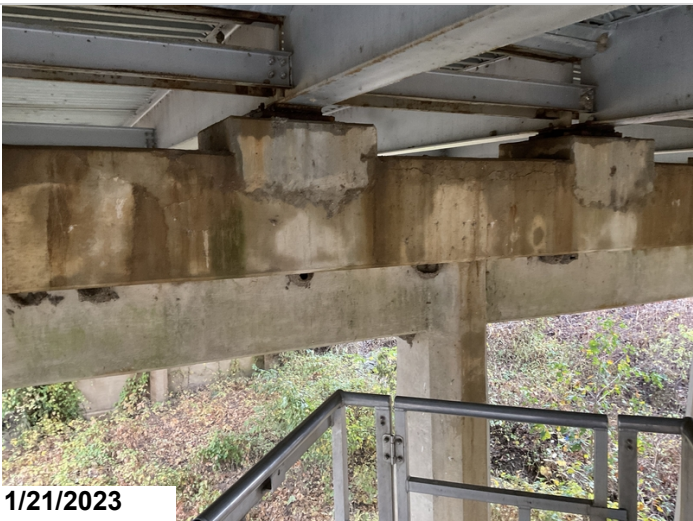
Bent #4 cap ahead face has horizontal cs3 cracks for 20' between girders #2, 5.

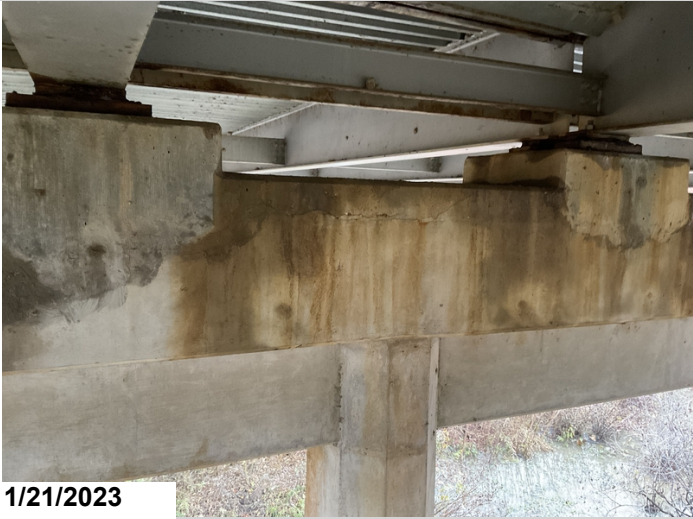
Bent #4 cap back face has horizontal cs3 cracks for 4' between girders #3 and 4.

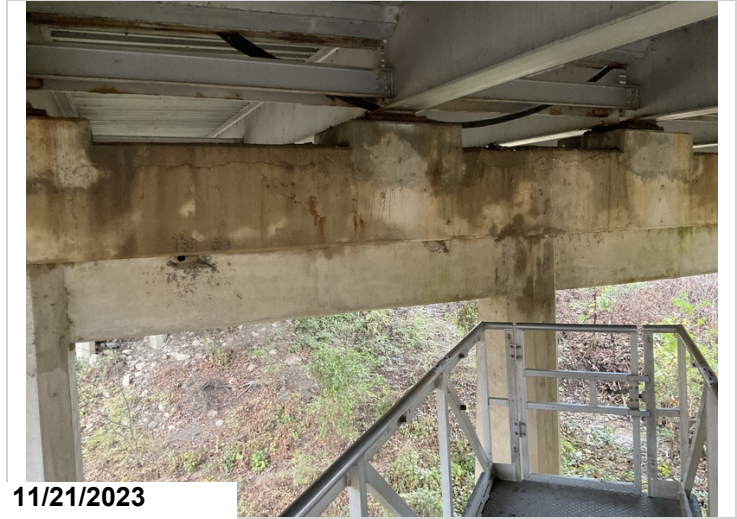
Bent #3 cap ahead face has horizontal cs3 cracks for 15' with a 2' delaminated area between girders #4, 5 between girders #3 and 5.

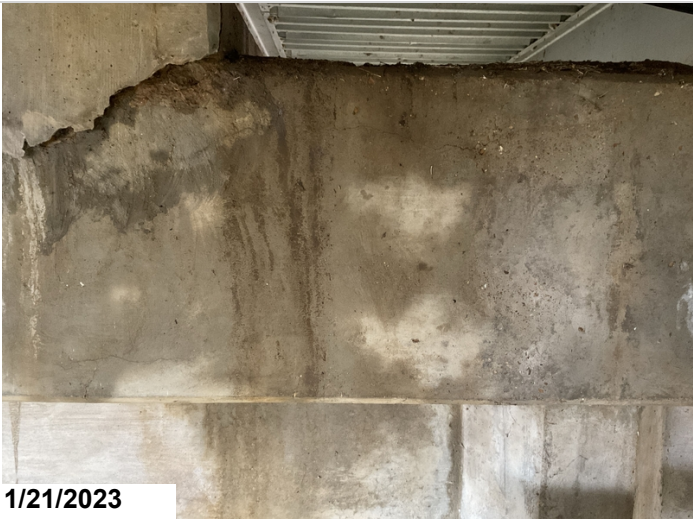
Bent #3 cap back face has cs2 cracks for 6' between girders #2, 5.

Bent #3 cap cracked for six feet back face between girders #2 and 5. Cs2

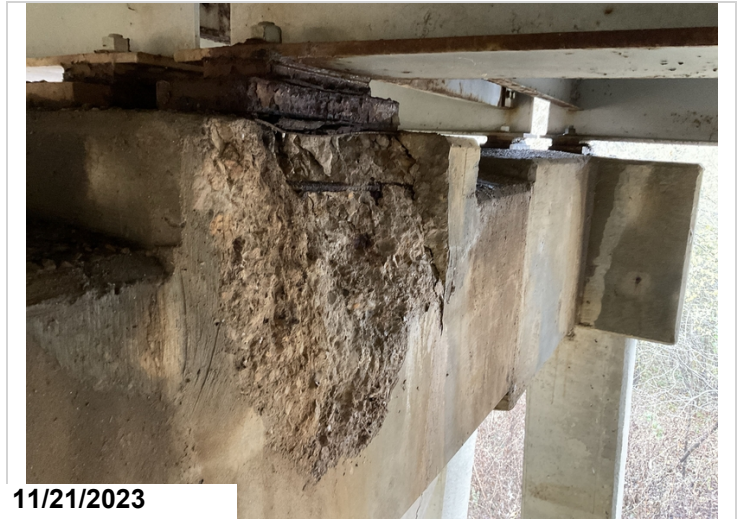
Bent #3 cap back face bearing riser spalled under girder #5 for 3' extending underneath bearing masonry plate up to 1" with exposed rebar moderate section loss.

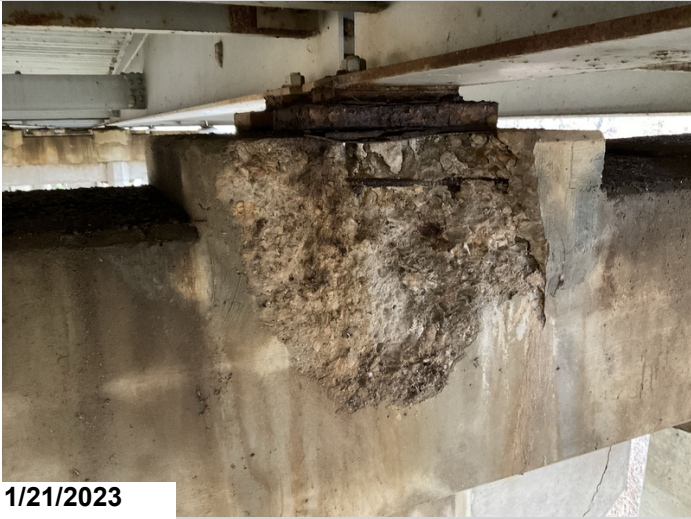
Bent #3 cap back face bearing riser spalled under girder #5 for 3' extending underneath bearing masonry plate up to 1" with exposed rebar moderate section loss.

Bent #3 cap back face spalled under span #2 girder #5 for two feet extending underneath bearing masonry plate up to one inch with exposed rebar

Bent #3 cap back face spalled under girder #5 for two feet extending underneath bearing masonry plate up to one inch with exposed rebar

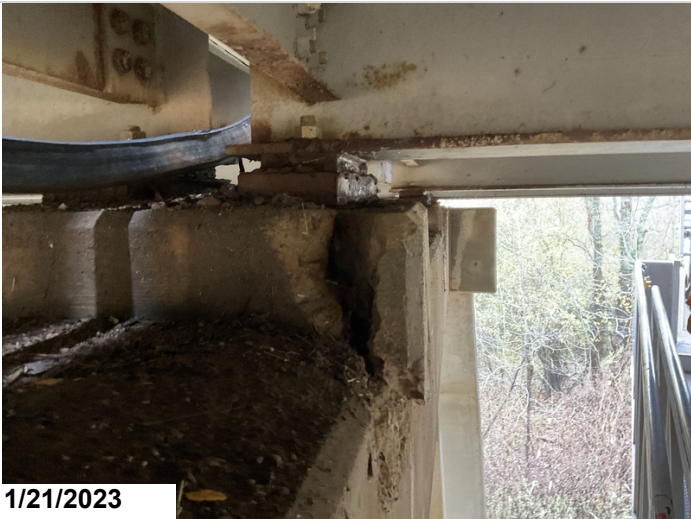
Bent #3 cap back face under girder #4 bearing riser has 3' crack with delamination extending underneath bearing masonry plates.

Bent #3 cap back face under span #2 girder #4 bearing riser has two foot crack with delamination extending underneath bearing masonry plates

Bent #3 cap back face under girders #4 bearing riser has three foot crack with delamination extending underneath bearing masonry plates.

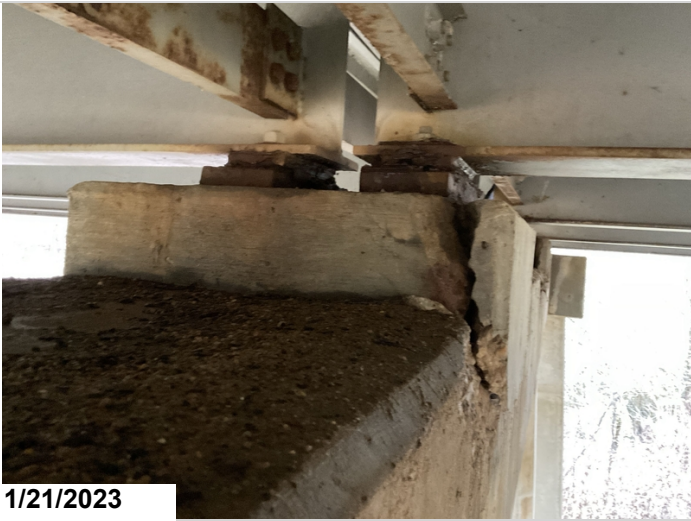
Bent #3 cap back face under girder #3 bearing riser is cracked and spalled for 3' extending under bearing masonry plate.

Bent #3 cap back face under girder #3 bearing riser has three foot crack with delamination extending underneath bearing masonry plates.

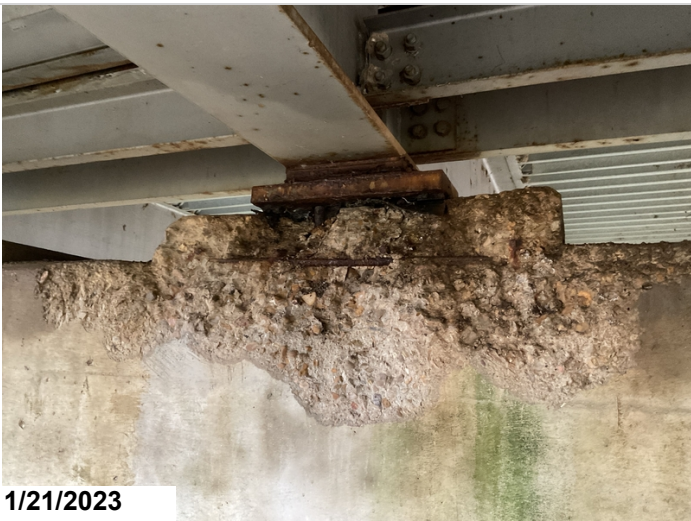
Bent #3 cap back face bearing riser is spalled for approximately 3.5 feet long and 3.5 inches under span #2 girder #2 extending up to 3" underneath bearing masonry plate with exposed rebar moderate section loss.

Bent #3 cap back face spalled for approximately 3.5 feet long under span #2 girder #2 extending up to three inches underneath bearing masonry plate with exposed rebar.

Bent #3 cap back face bearing riser spalled for approximately 3.5 feet under span #2 girder #2 extending up to three inches underneath bearing masonry plate with exposed rebar

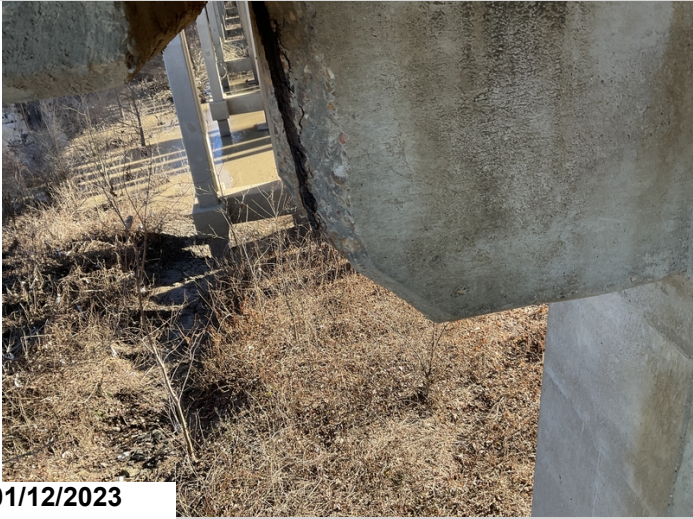
Bent #3 cap left side between pile #1, 2 and column #1 is spalled with exposed rebar moderate section loss (end of original cap).

Bent #3 cap left side between pile #1, 2 and column #1 spalled with exposed rebar (end of original cap).
Bent #3 cap right side between pile #3, 4 and column #3 spalled with exposed rebar (end of original cap).
Bent #3 cap cracked for six feet back face between girders #2 and 5. Cs3
Bent #3 cap ahead face between girders #3 and 5 has horizontal cracking for 15' with a two foot delaminated area between girders #4 and 5. Cs3
Bent #4 cap right end has vertical hairline crack
Bent #4 cap ahead face has horizontal cracking between girders #2 and 5 for twenty feet. Cs3
Bent #4 cap back face between girders #3 and 4 has four foot of horizontal cracking. Cs3
Bent #4 cap bottom left corner near column #1 has one foot spall exposed rebar with 15% section loss. Right end of old cap section at bent # 3&5 have small spalls with exposed rebar due to poor coverage 5% section loss
Bent #5 cap back face at top cracked horizontally for twelve feet. Cs3

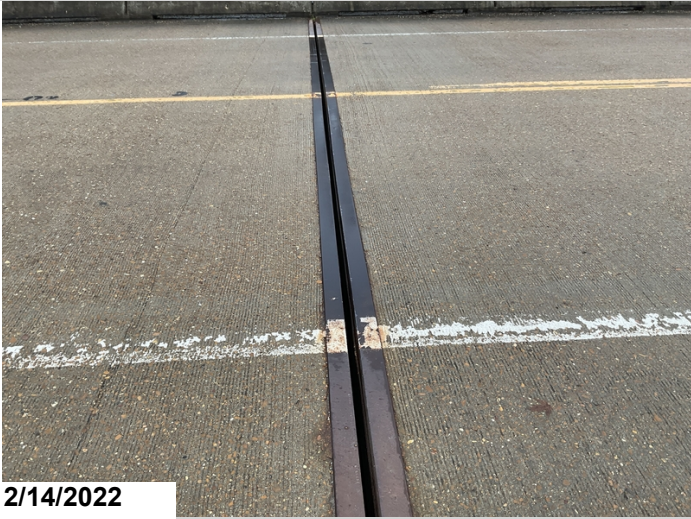
Bent #8 joint has fallen out

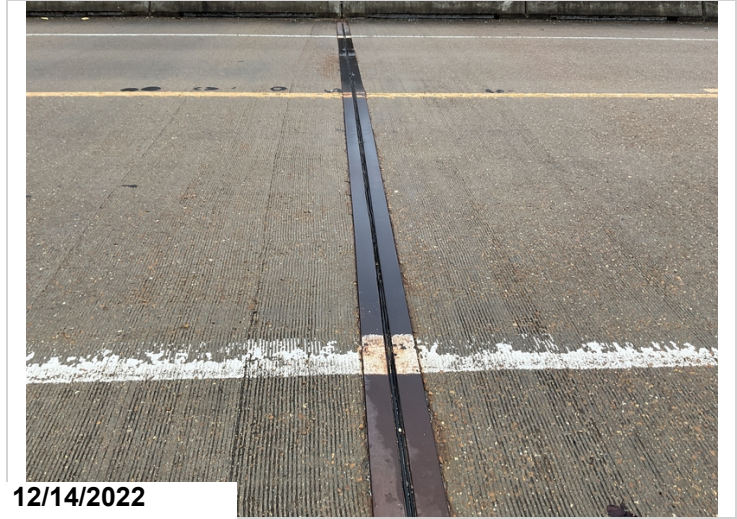
Bent #7 joint has fallen out

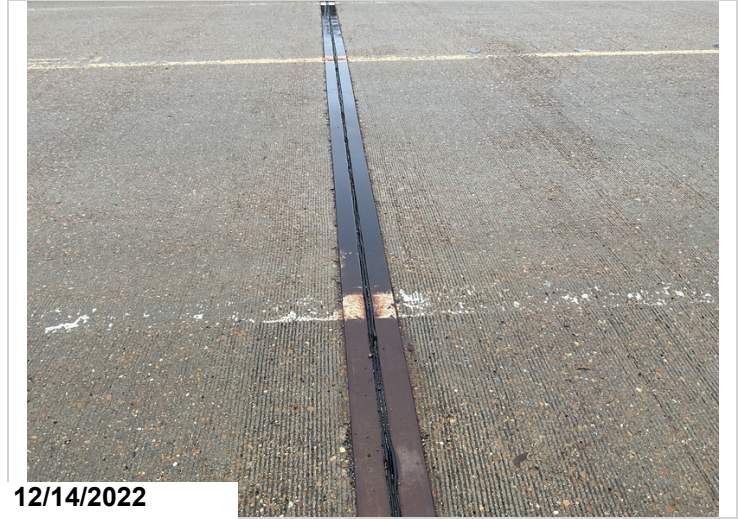
Bent #3 joint seal has 10' that has fallen out and 8' with lost adhesion and sagging

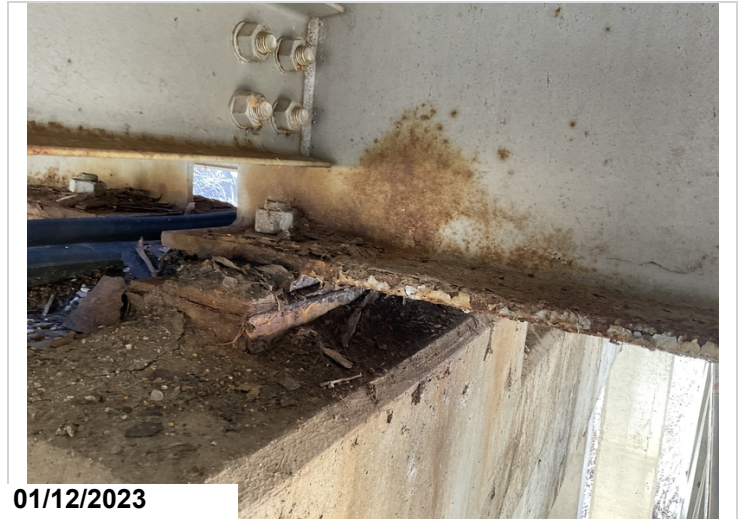
Abutment #1 joint seal weathered and torn

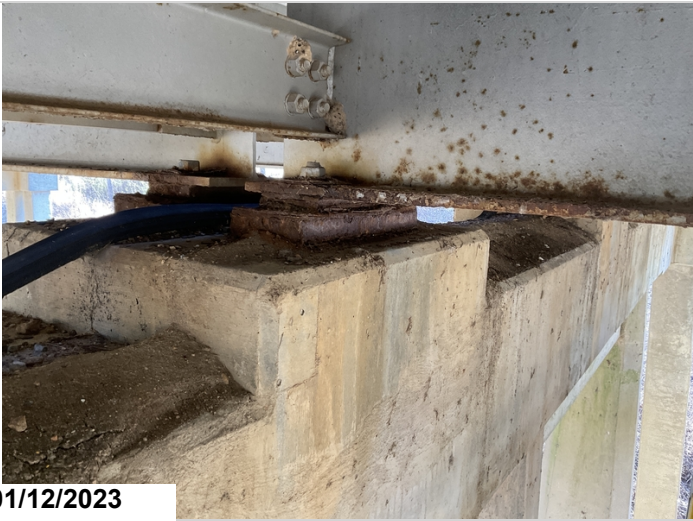
Corrosion on bearings and girder ends

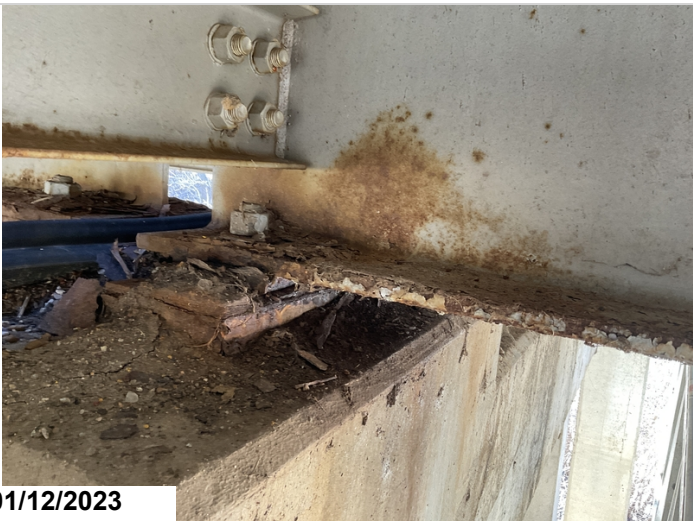
Span #6 bent #6 girder #2 right anchor bolt broken.

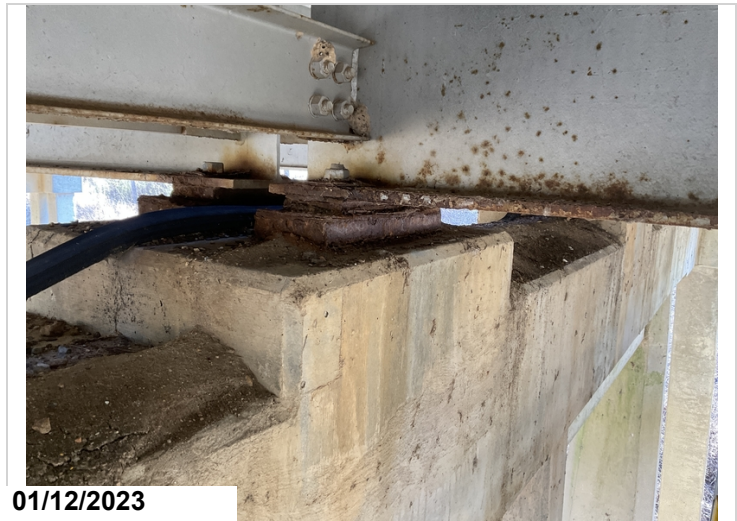
Corrosion on bearings and girder ends

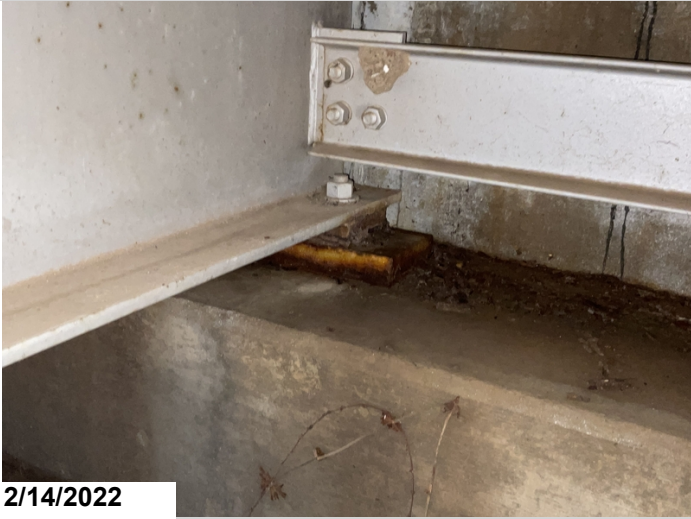
Bent #7 corrosion on girder ends and bearing.

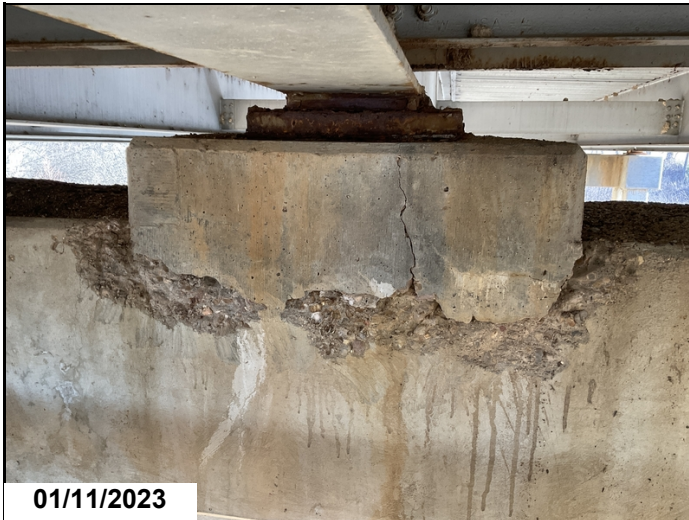
Bent #3 cap back face bearing riser under girders #4 bearing risers have three foot crack with delamination extending underneath bearing masonry plates.

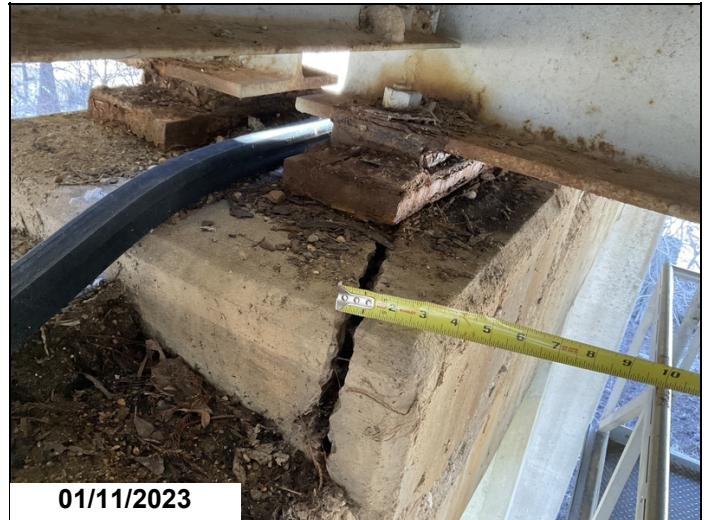
Bent #8 cap ahead face cracked and delaminated and spalled under girder #3, full width of riser.

Bent #8 cap ahead face bearing riser cracked and delaminated and spalled under girder #3.

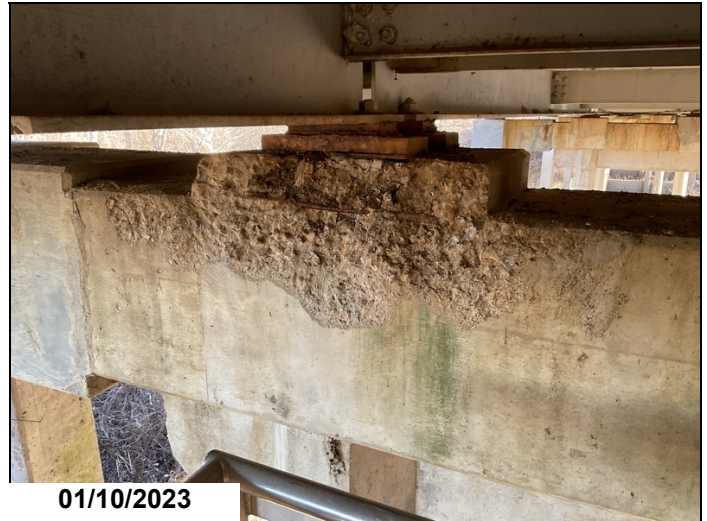
Bent #3 cap back face bearing riser spalled for approximately 3.5 feet under span #2 girder #2 extending up to three inches underneath bearing masonry plate with exposed rebar

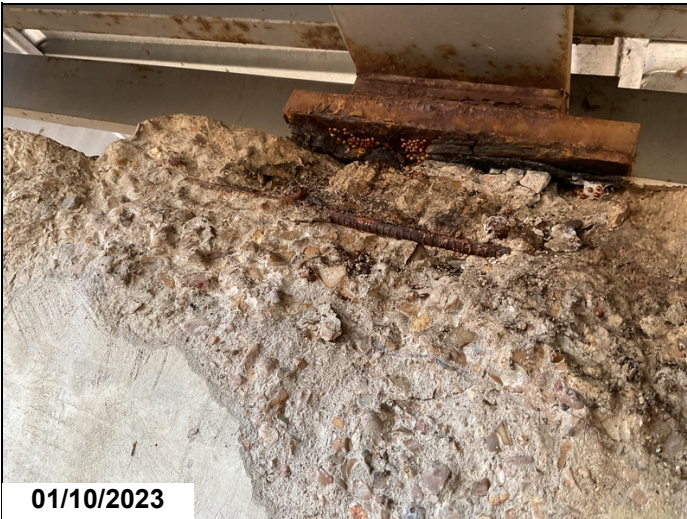
Bent #3 cap back face bearing riser spalled for approximately 3.5 feet under span #2 girder #2 extending up to three inches underneath bearing masonry plate with exposed rebar

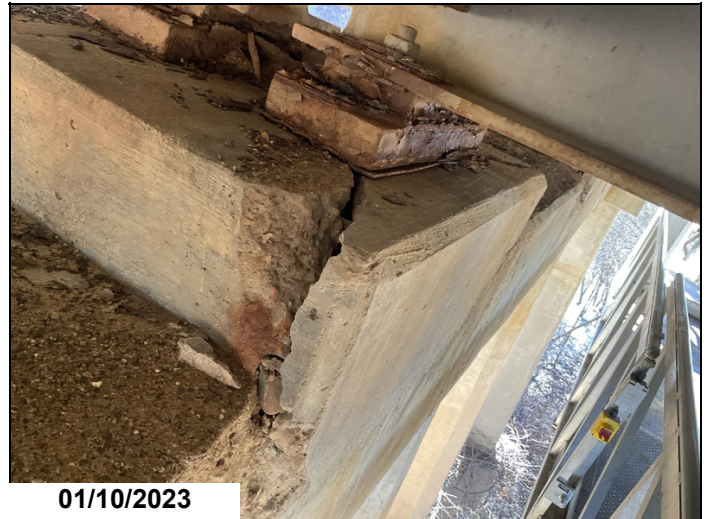
Bent #3 cap back face bearing riser under girder #3 bearing risers have three foot crack with delamination extending underneath bearing masonry plates.

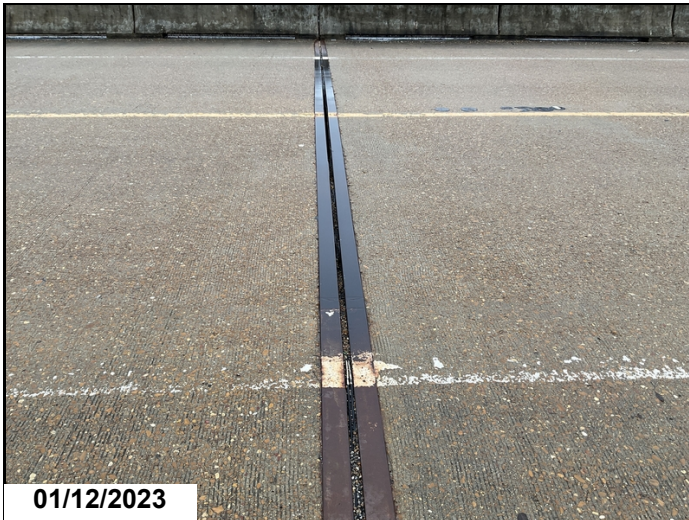
Joint seal at bent #3 is hanging down for ten feet in the center.
Joint seals at bents #7,8 have failed and fallen down onto cap.

Bent #3 joint seal has 10' that has fallen out and 8' with lost adhesion and sagging

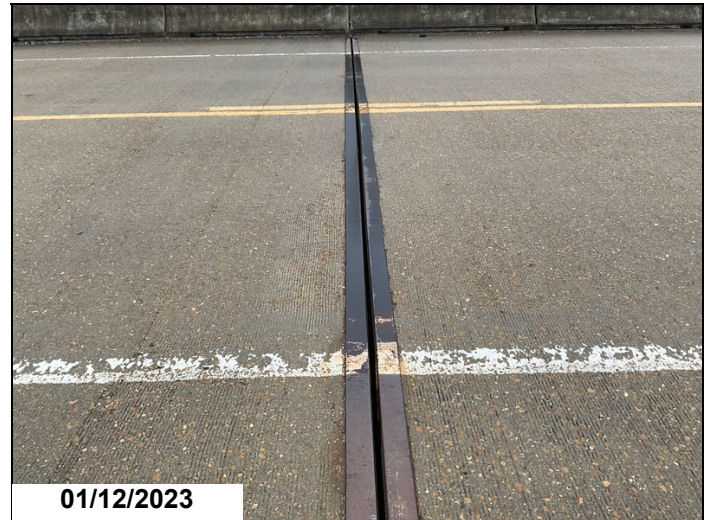
Bent #8 joint has fallen out

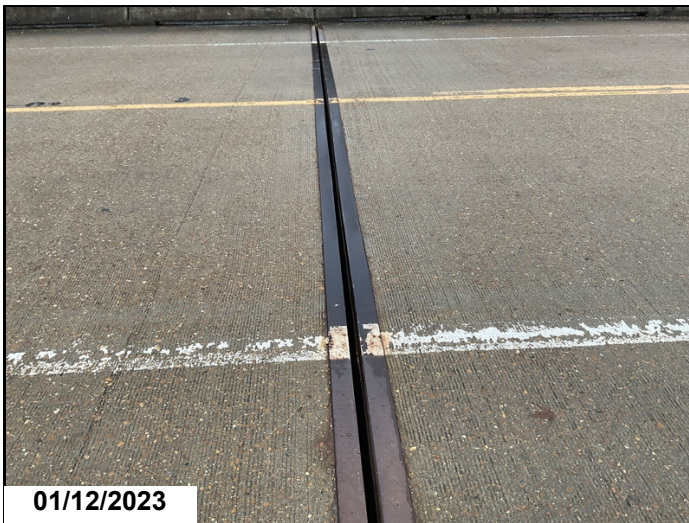
Bent #7 joint has fallen out

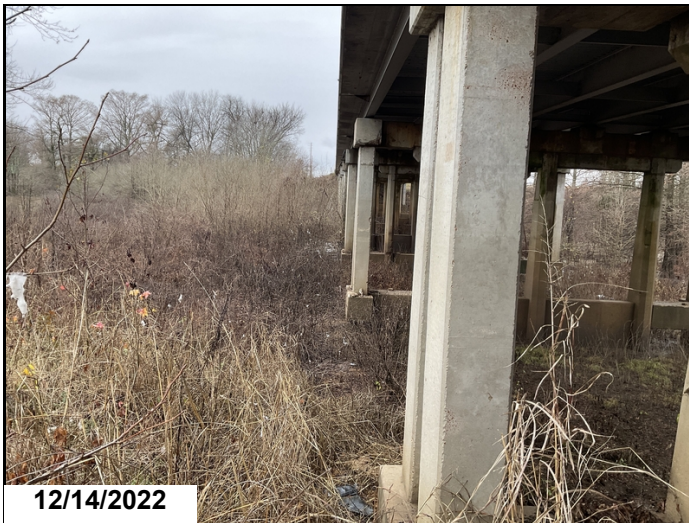
Small trees and vegetation are growing under and beside bridge with a few bents with vines growing on them.

Vegetation growing beside and under bridge

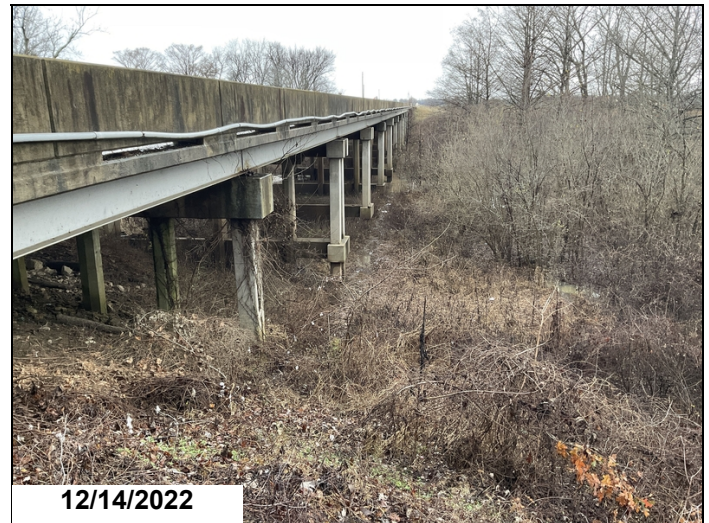
Trees and vegetation growing beside and under bridge

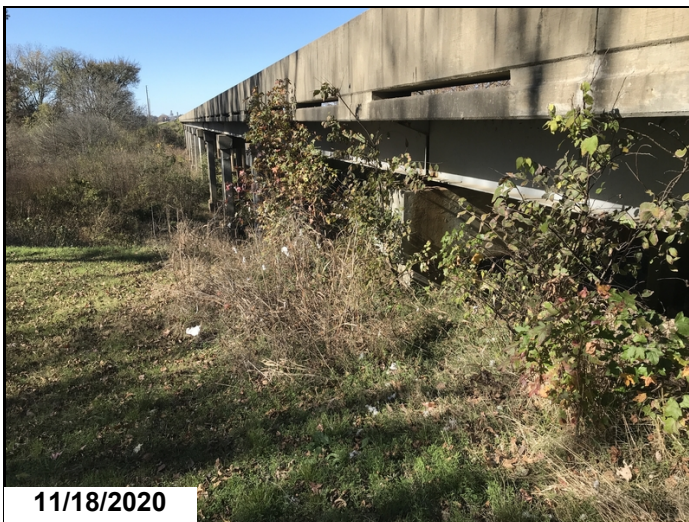
Vegetation is growing beside and under bridge.

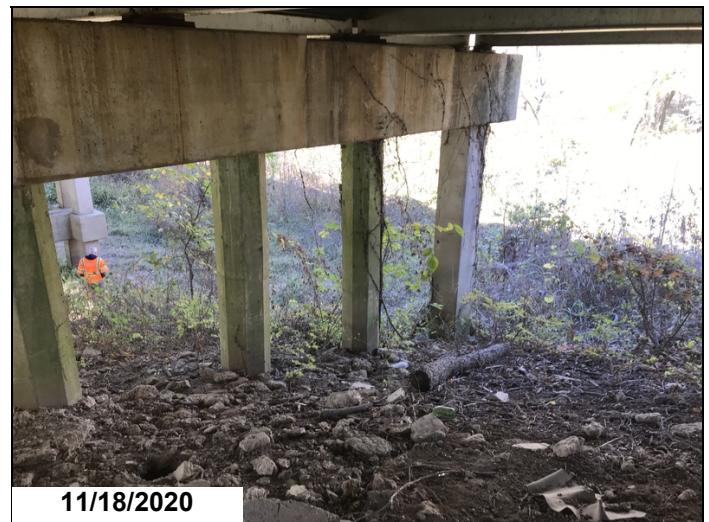
Vegetation growing on bent #11.

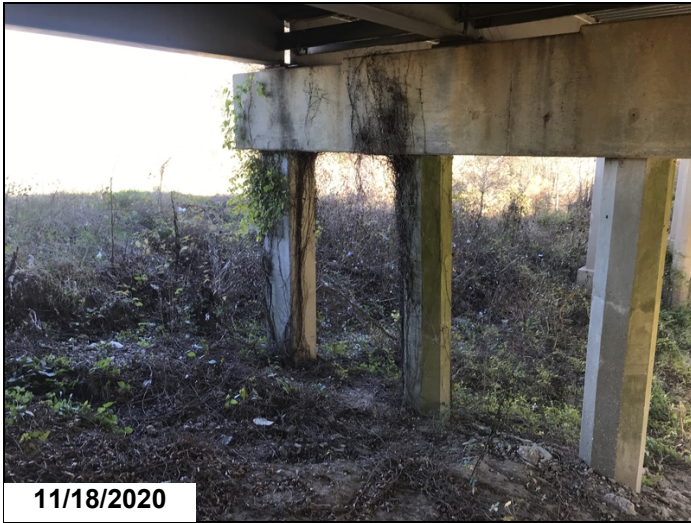
Bent #2 vines growing on bent.

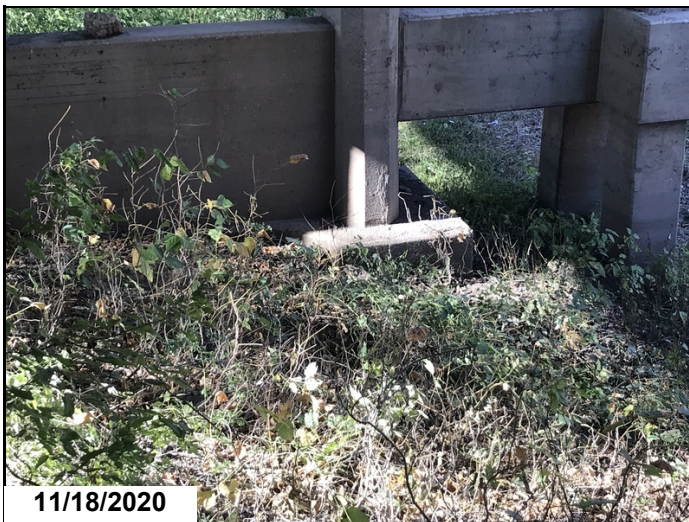
Bent #10 footing on left end is exposed two feet.

Bent #10 footing on left end is exposed 2'.

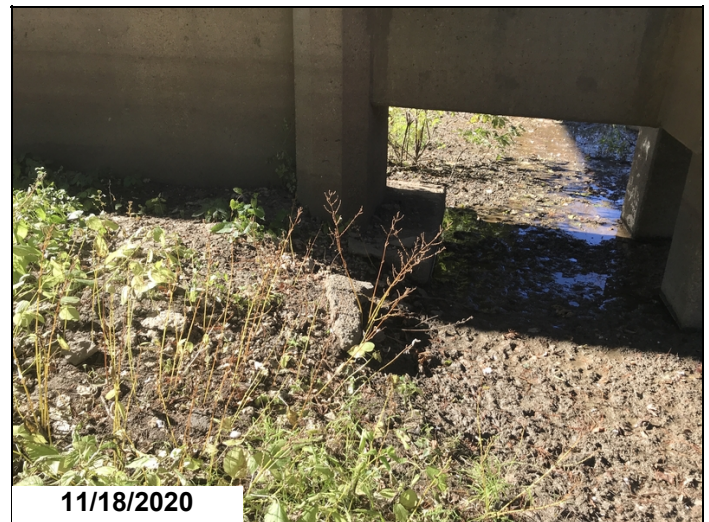
Bent #7 footing on left end is exposed 1 1/2'.

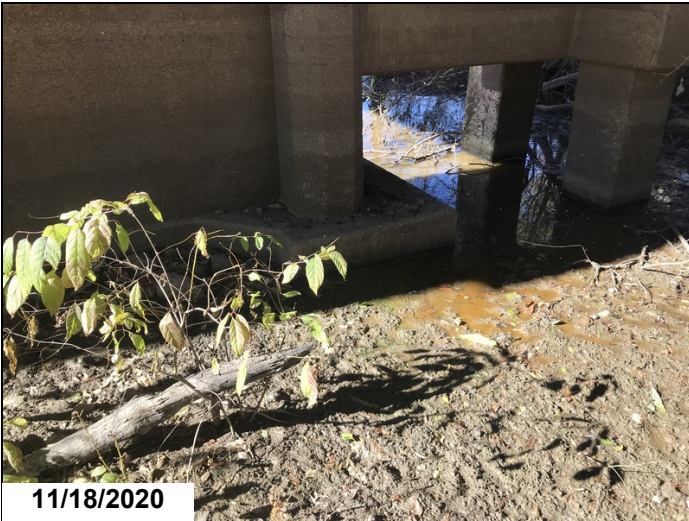
Bent #6 footing exposed full length left side and 1 1/2' to ground level on right.

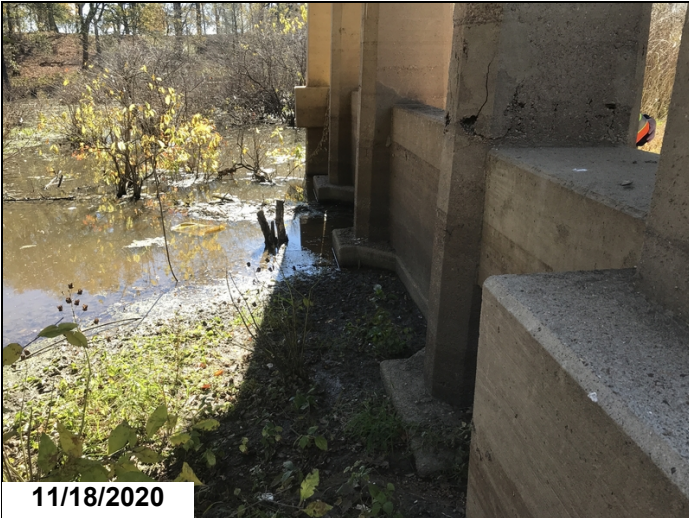
Bent #3 footing on right end exposed 1 1/2 foot.

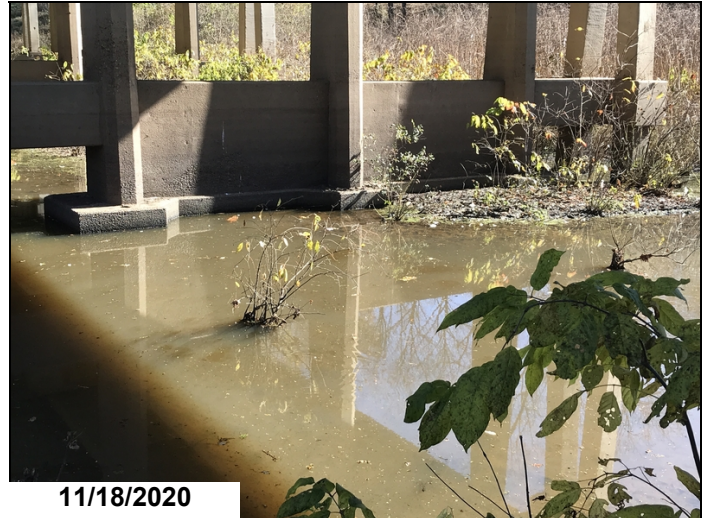
Bent #4 footing exposed right end 2' and 3' on the left end.

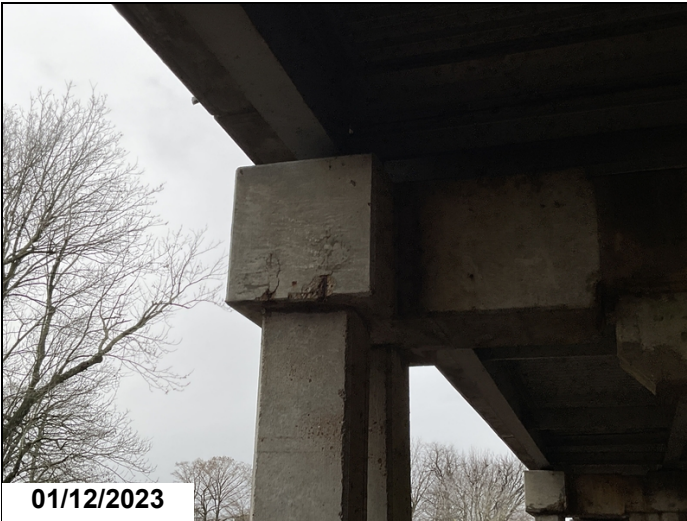
Bent #10 cap ahead face right side has a six inch delamination and a four inch spall with exposed rebar with 10% section loss.

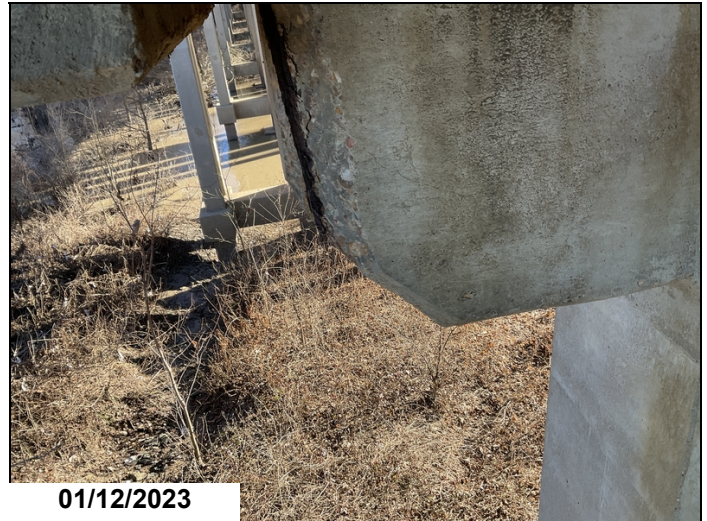
Bent #3 cap left side between pile #1 and column #2 spalled with exposed rebar

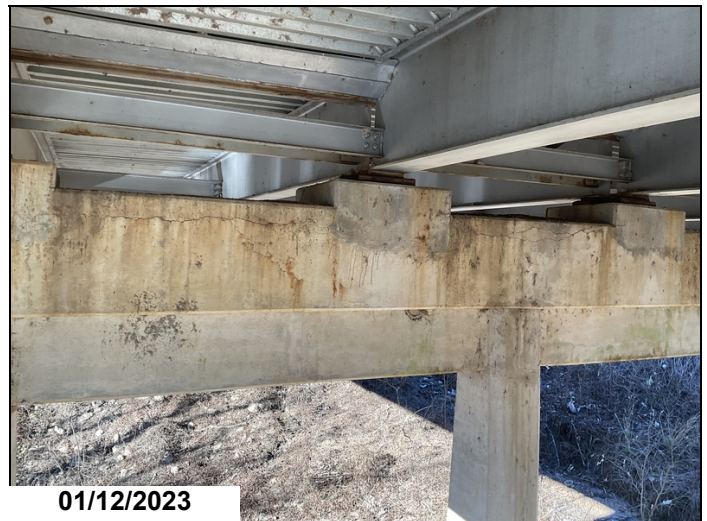
Bent #3 cap ahead face between girders #3 and 5 has horizontal cracking for 15' with a two foot delaminated area between girders #4 and 5. Cs3

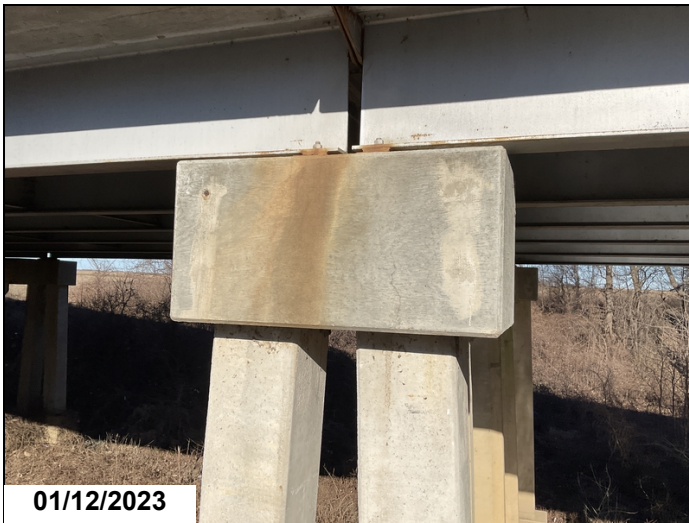
Bent #4 cap right end has vertical hairline crack

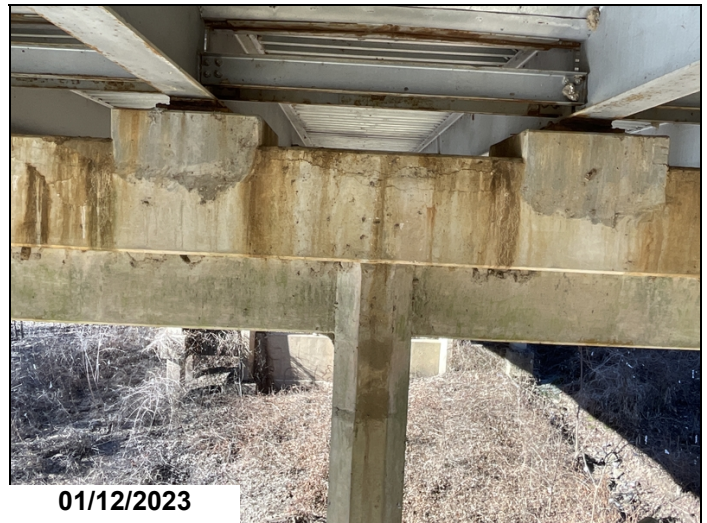
Bent #4 ahead face has horizontal cracking between girders #2 and 5 for twenty feet. Cs3

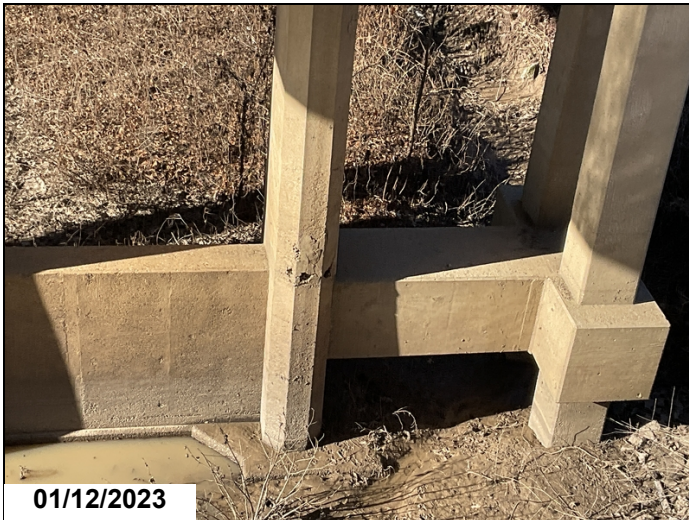
Bent #4 column #1 ahead face has one foot delaminated area with spalling at footing.

Bent #4 column #1 ahead face has a one foot delaminated area with spalling and honeycomb. Cs3

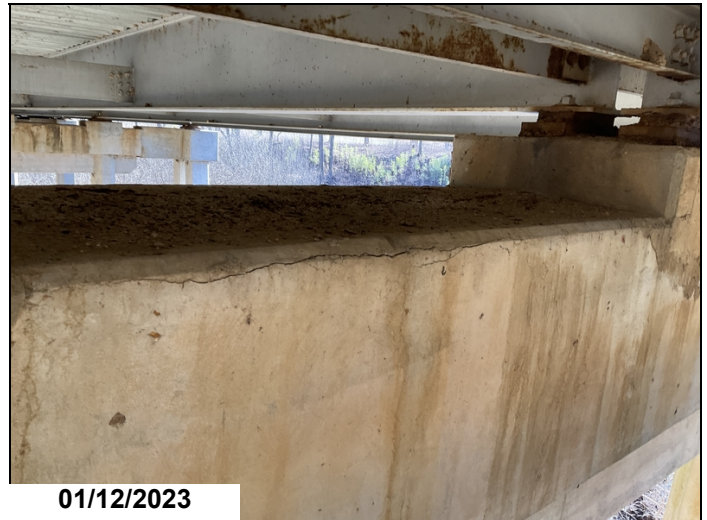
Bent #5 cap back face at top cracked horizontally for twelve feet. Cs3

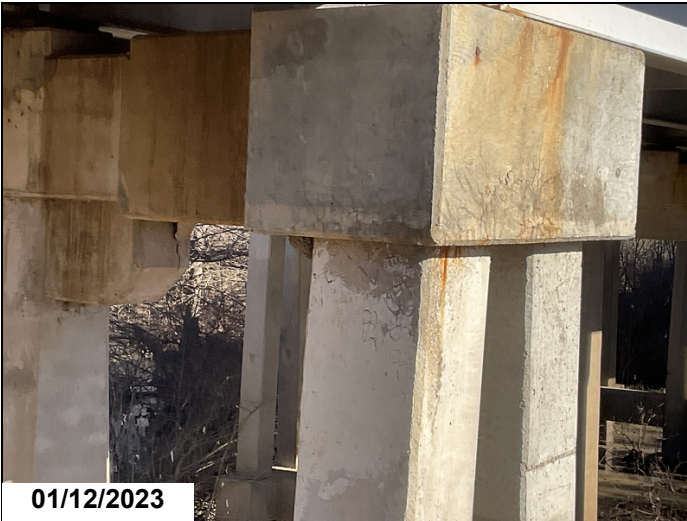
Bent #5 cap right side of original cap delaminated on end.
Bent #5 cap right end has one foot of cracking and delaminated area.

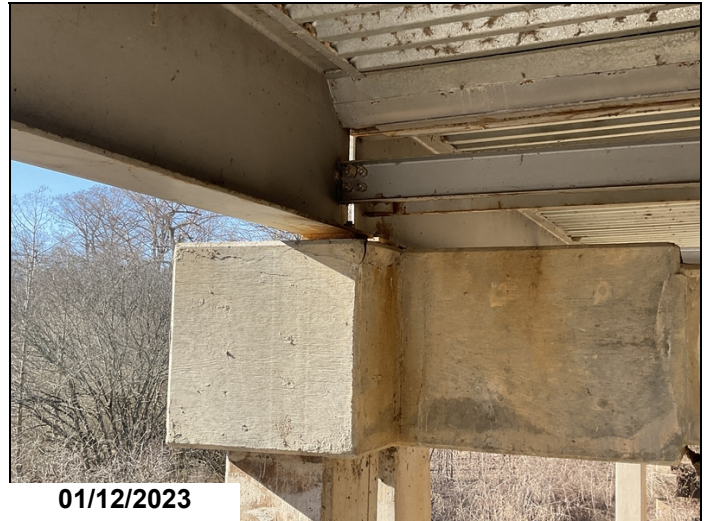
Bent #5 cap ahead face right side extension cracked and delaminated for two feet at top.

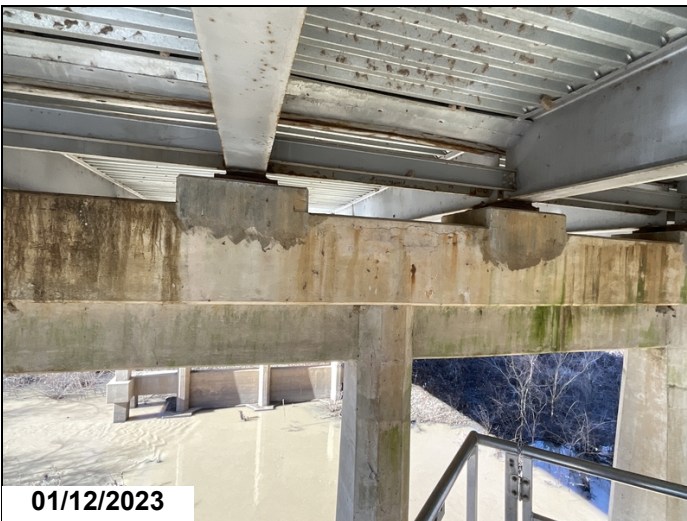
Bent #5 cap ahead face cracked horizontally between girders #3 and 5 twenty feet near top. Cs3

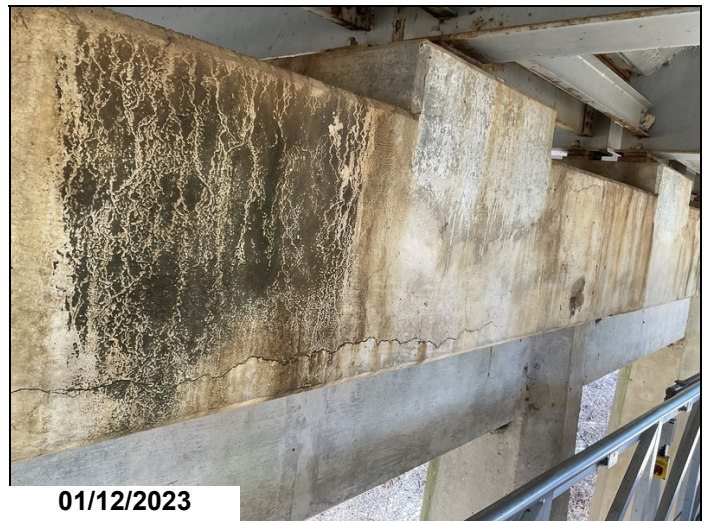
Bent #6 cap back face has ten feet of cracking between girders #2 and 5.

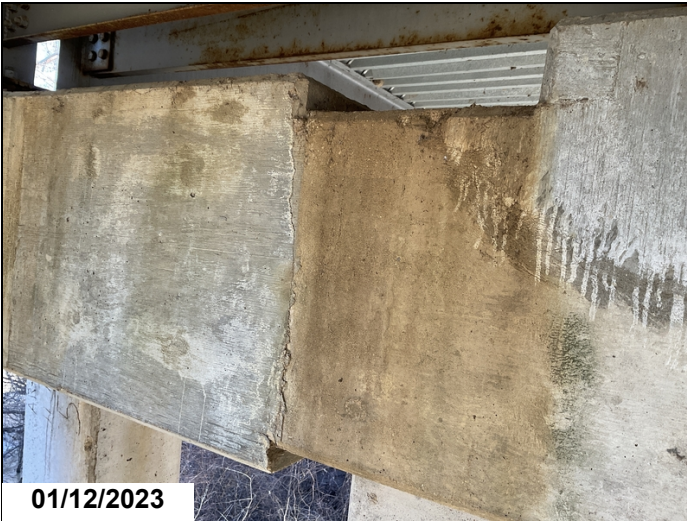
Bent #6 cap has vertical crack at cold joint between girders #1 and 2.

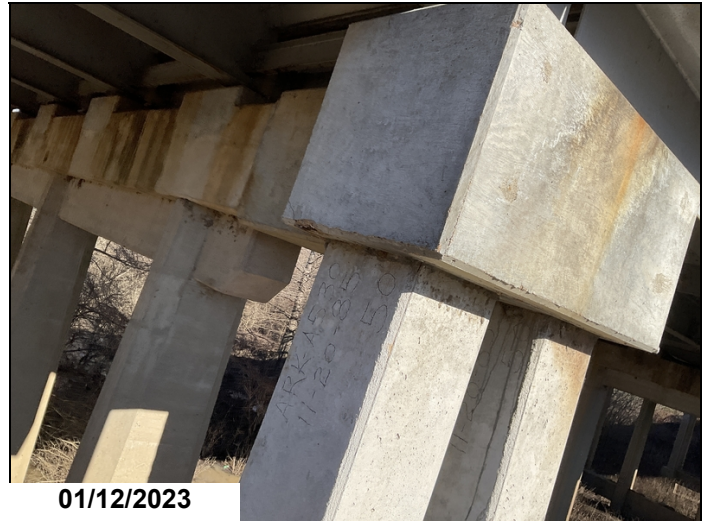
Bent #6 cap back face right side has small spall on corner with exposed rebar.

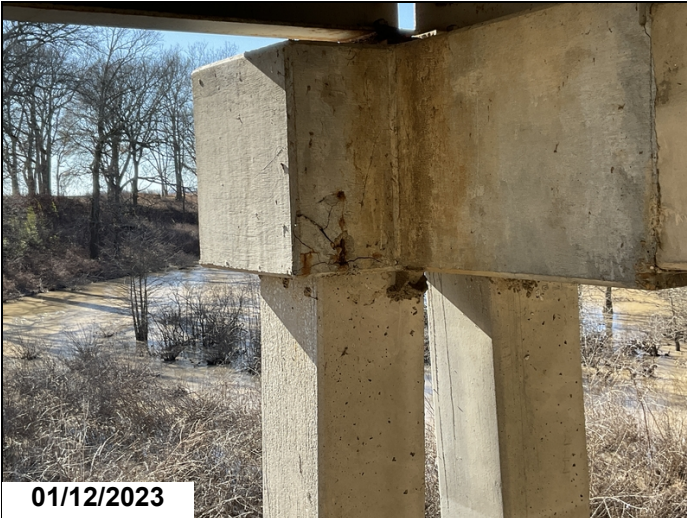
Bent #6 cap ahead face right side under girder #6 cracked and delaminated for one foot with exposed rebar

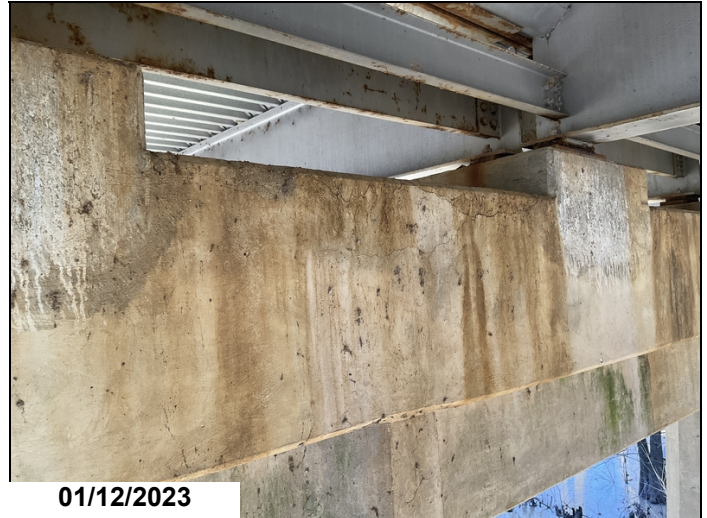
Bent #6 cap ahead face between girders #3 and 4 cracked horizontally for four feet

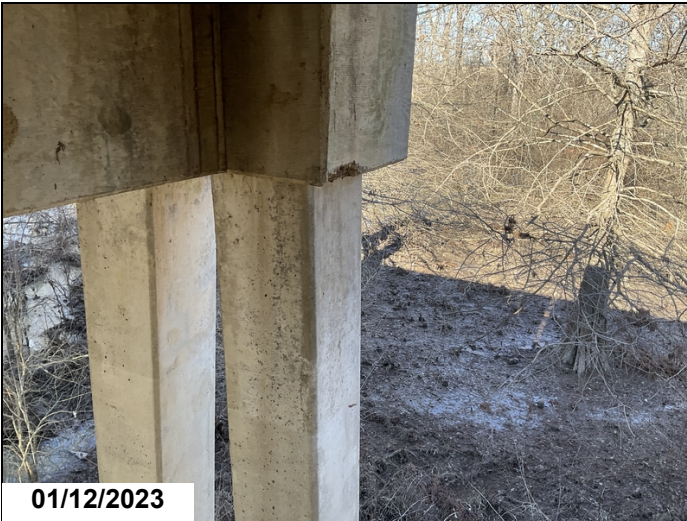
Bent #8 cap ahead face left side bottom corner has one foot spall with exposed rebar

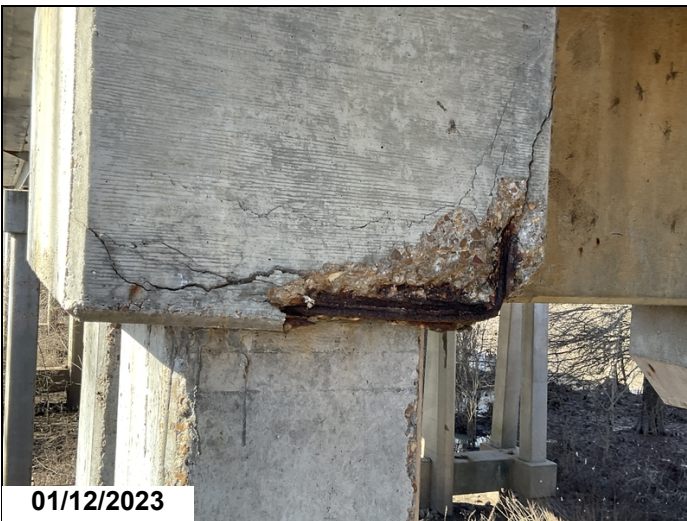
Bent #9 cap ahead face right side cracked and spalled with exposed rebar for two feet

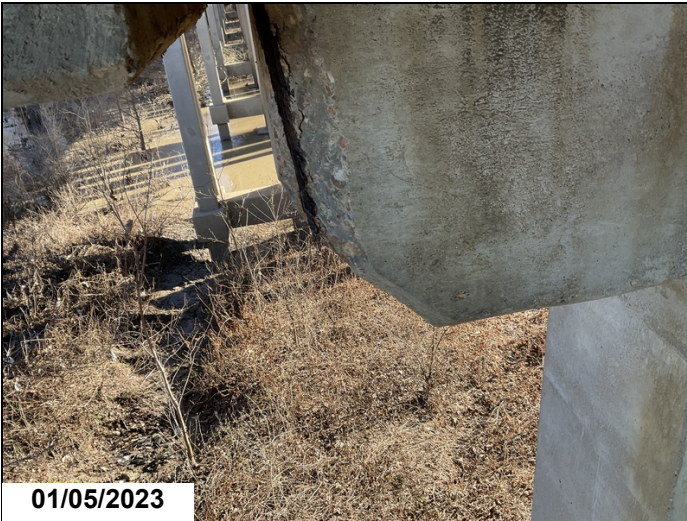
Bent #3 cap left side between pile #1 and column #2
spalled with exposed rebar

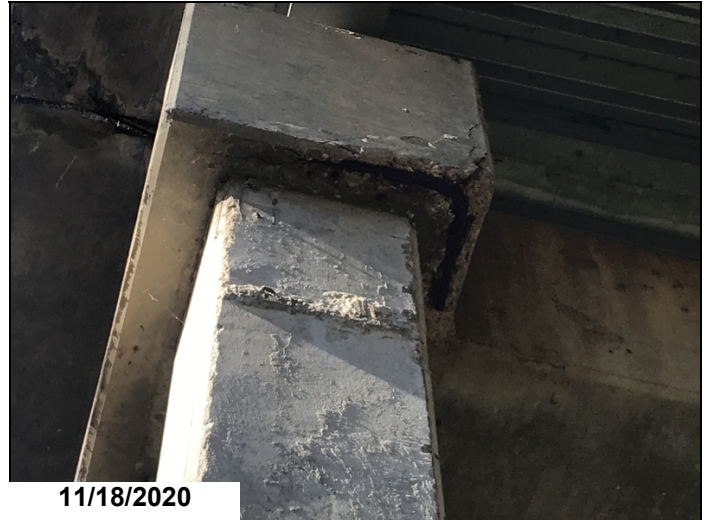
Bent #9 cap has two foot spall right end with exposed
rebar 10% section loss on bottom cord backface and left
end.
