Asset #02534(Other Special Recurring)

Us-79/Sec16/L11.51 over Alligator Bayou

Location: .7 Mi South Of Brickeys

Team Lead: Drew Melton Inspection Date: 11/21/2023

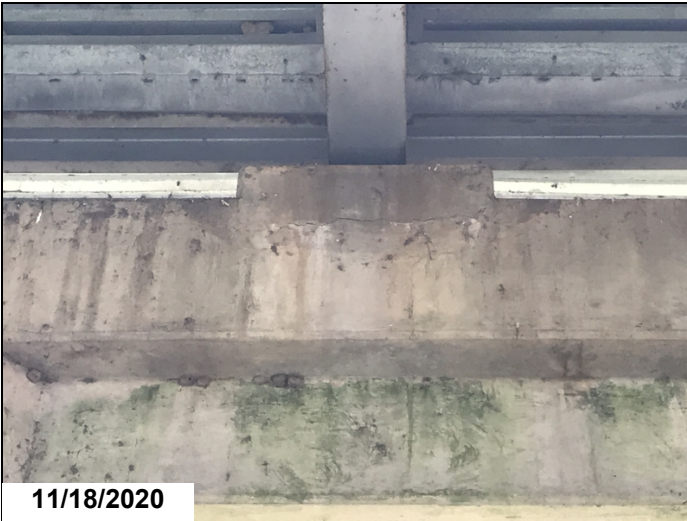
Bent #8 cap ahead face bearing riser under girder #3 is cracked longitudinally full width.

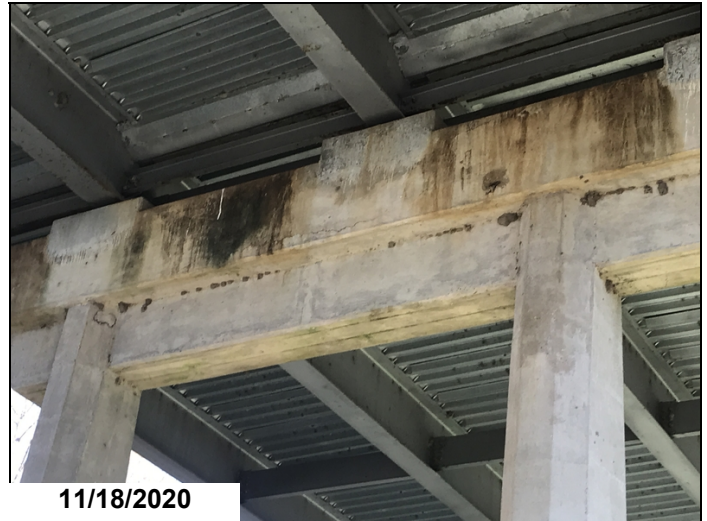
Bent #6 cap back face has 4' long crack under girder #3.

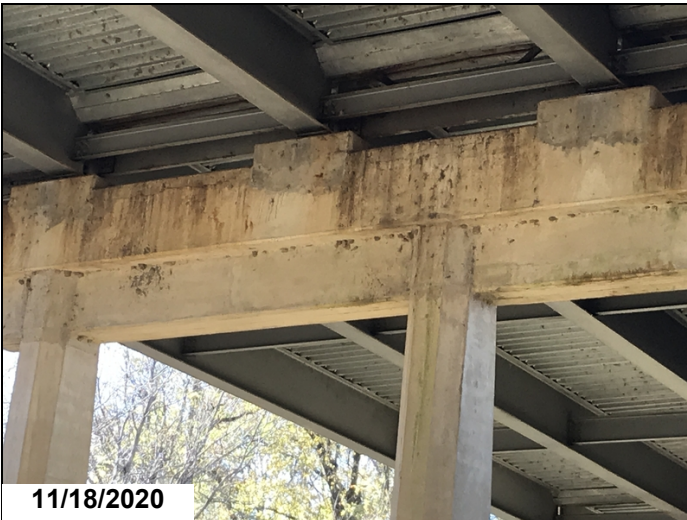
Bent #3 cap ahead face is cracked near top for twenty feet between girders #3,5.

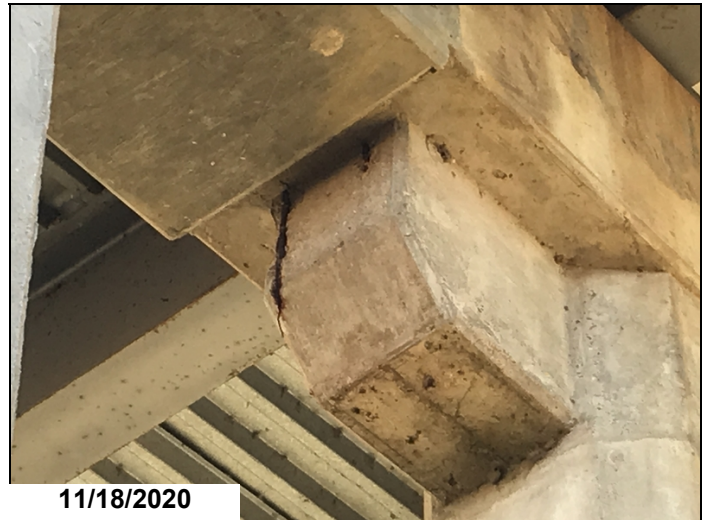
Bent #4 cap bottom left corner near column #3 has one foot spall exposed rebar with 15% section loss.

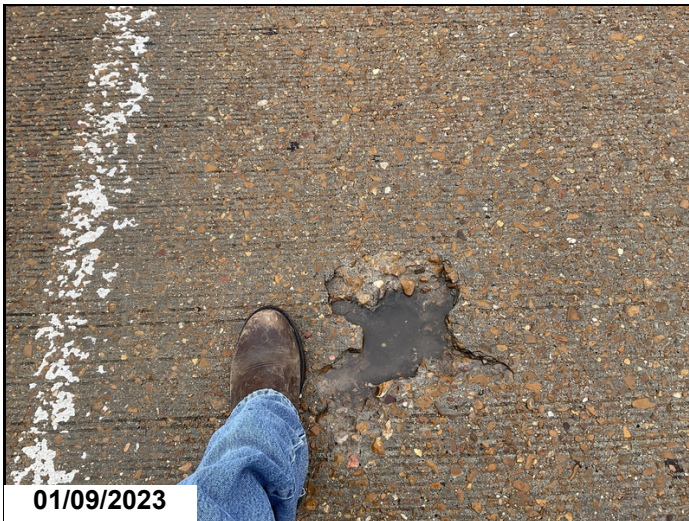
Span #5 deck, left lane, near mid span has one foot spall with no exposed rebar.

Span #5 deck left lane has one foot spall near mid span

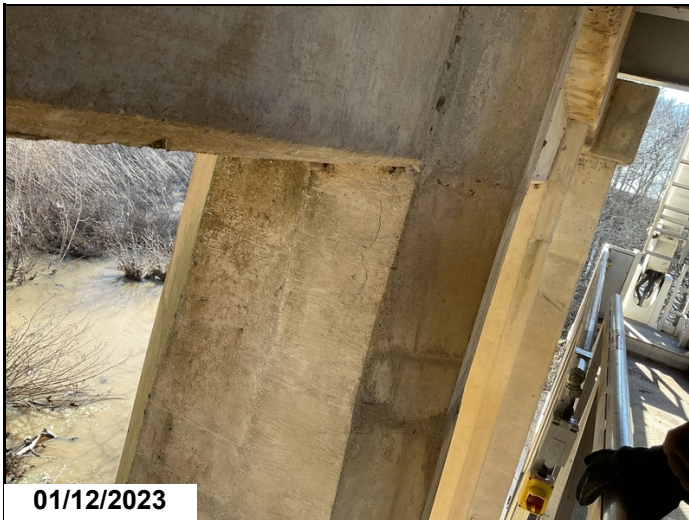
Bent #4 column #2 has one foot of vertical cracking near top. Cs2

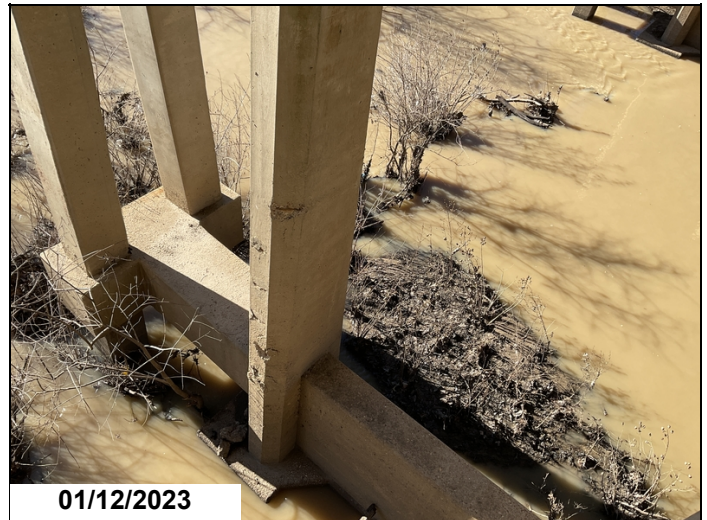
Bent #5 column #3 ahead face has several exposed rebar areas due to poor concrete coverage 5% section loss.

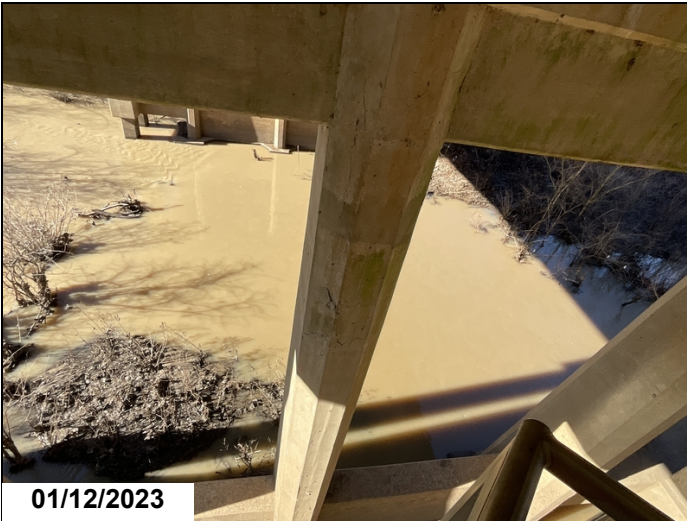
Bent #3 column #2 ahead face has five feet of cracking and delaminated area. Cs3

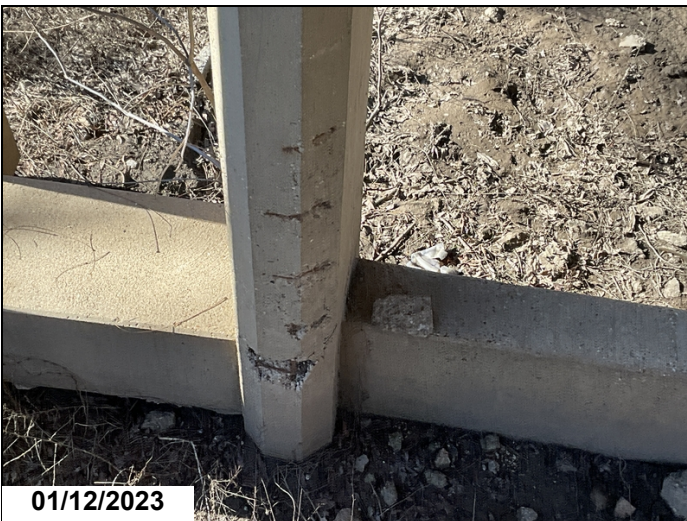
Bent #8 column #3 is spalled on ahead face four foot above ground with five feet of exposed rebar 5% section loss.

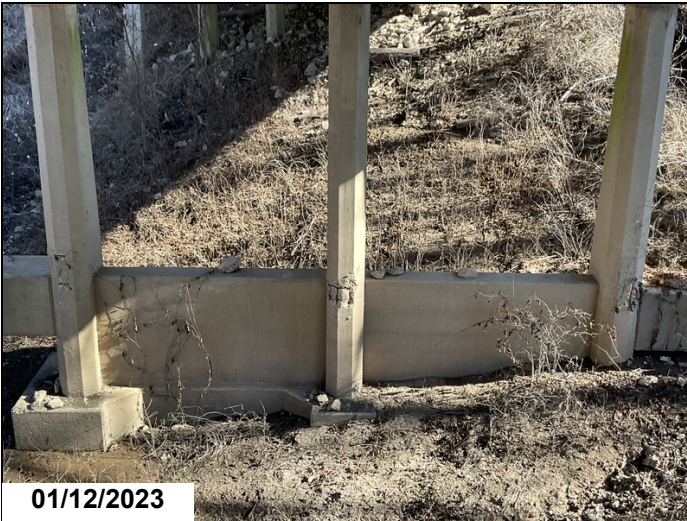
Bent #10 column #1, 2, 3 each have one foot spalls four foot above ground on the back face with rebar exposed 10% section loss.

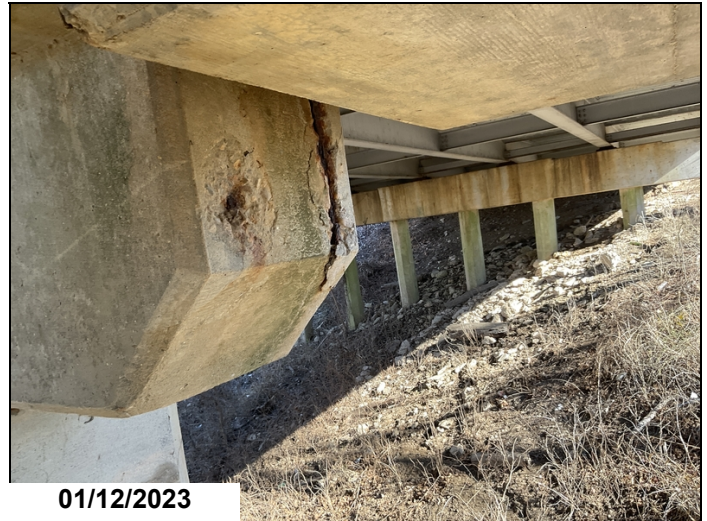
Bent #10 cap ahead face right side has a six inch delamination and a four inch spall with exposed rebar with 10% section loss.

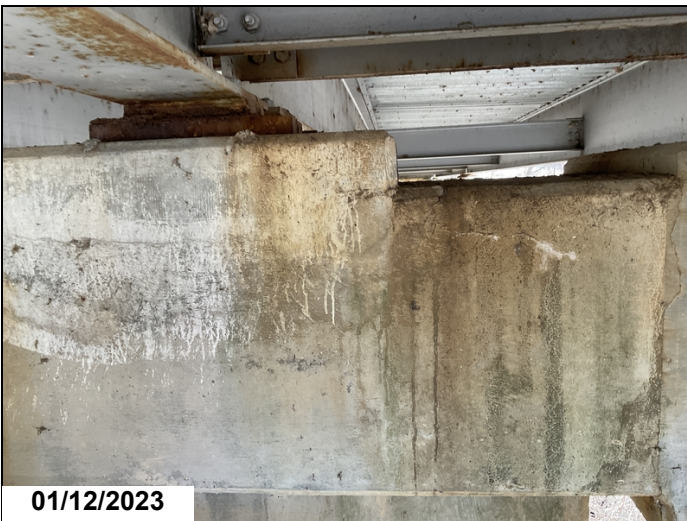
Bent #10 cap back face under girder #5 has two feet of horizontal cracking with light efflorescence

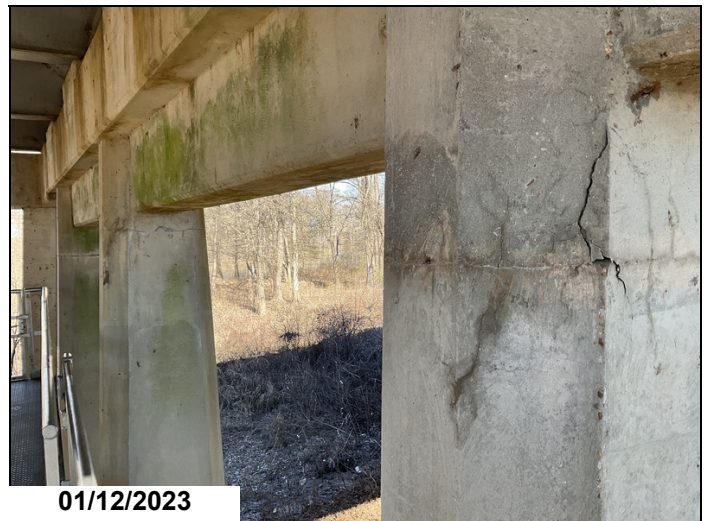
Bent #10 columns #1, 2, 3 have horizontal cracking with light efflorescence six inches to one foot below cap.

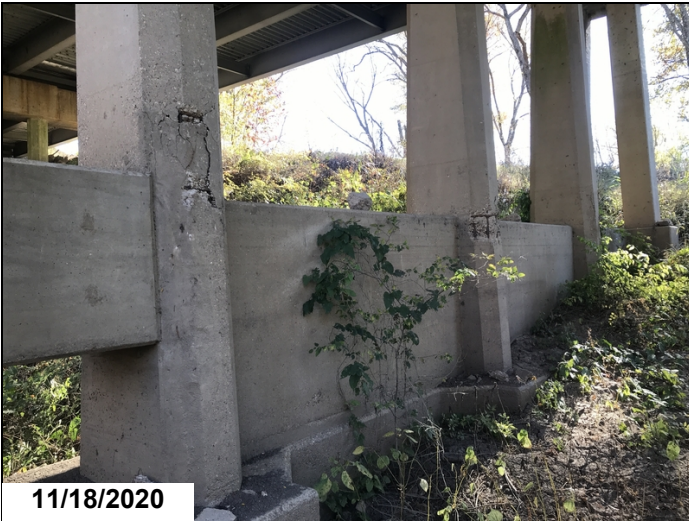
Bent #10 column #3,4,5 have 1' spalls 4' above ground on the back face with rebar exposed 10% section loss.

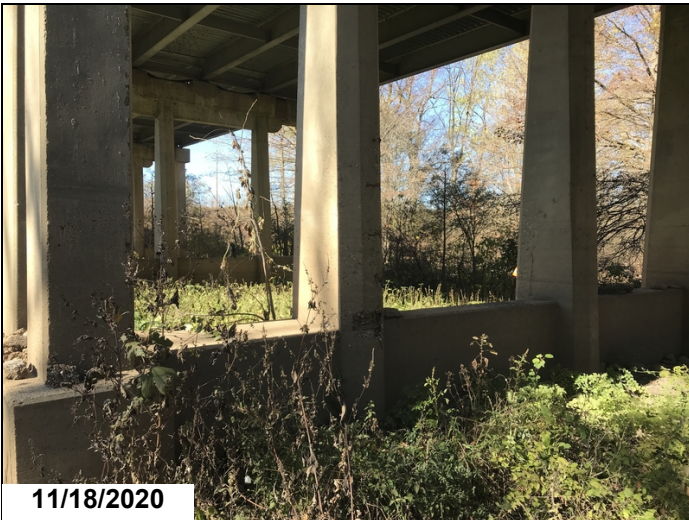
Bent #8 column #4 is spalled on ahead face 4' above ground with five feet of exposed rebar 5% section loss.

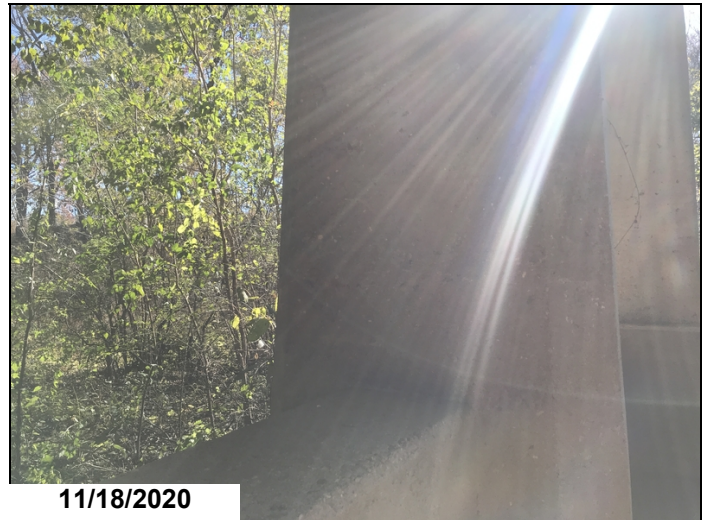
Bent #7 column #5 left side has 2 pieces of exposed rebar due to poor concrete coverage.

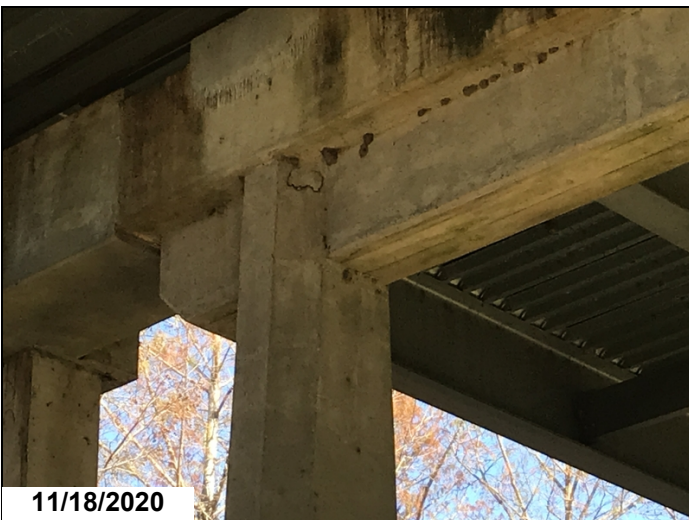
11/18/2020

Bent #6 column #3 backface at top has 1' delamination.

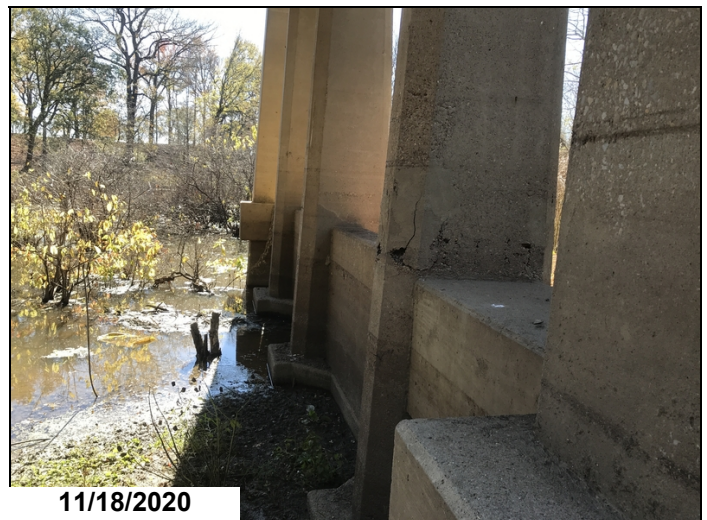
11/18/2020

Bent #4, column #3 ahead face has 1' area of spall and honeycomb.

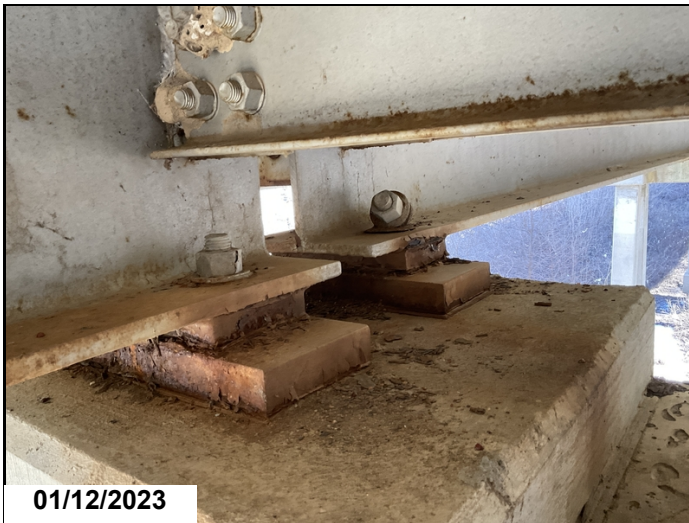
Span #6 bent #6 girder #2 right anchor bolt broken.

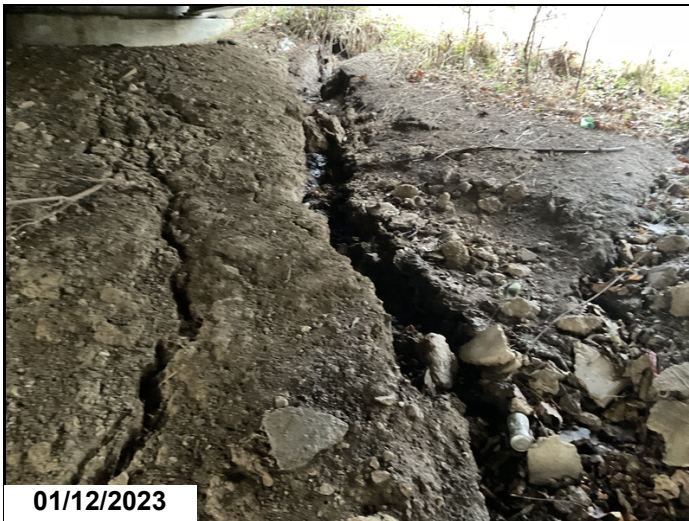
Abutment #2 slope right side has erosion vein up to 2' deep due to roadway runoff

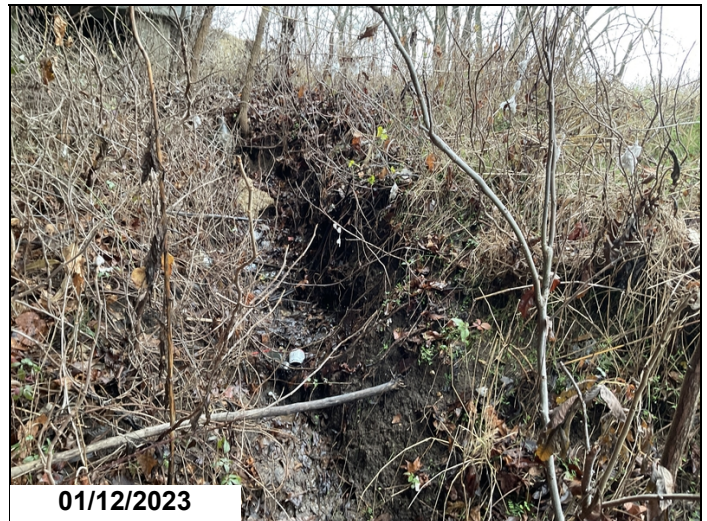
Span #10 slope right side eroded up to three feet deep under deck drains

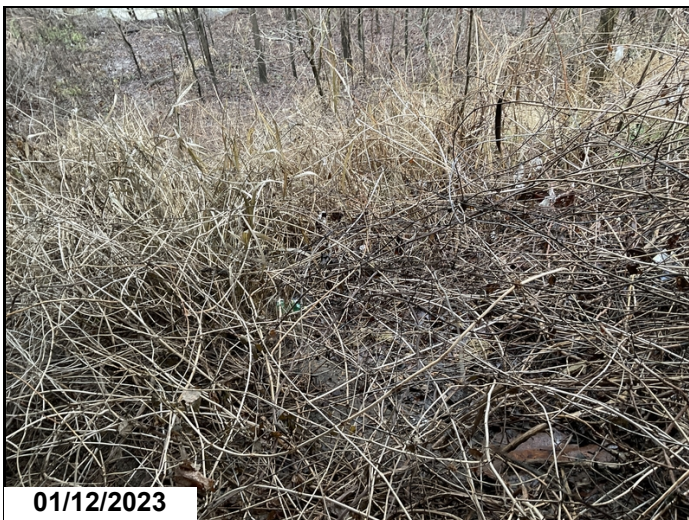
Span #1 right slope has minor erosion under deck drains

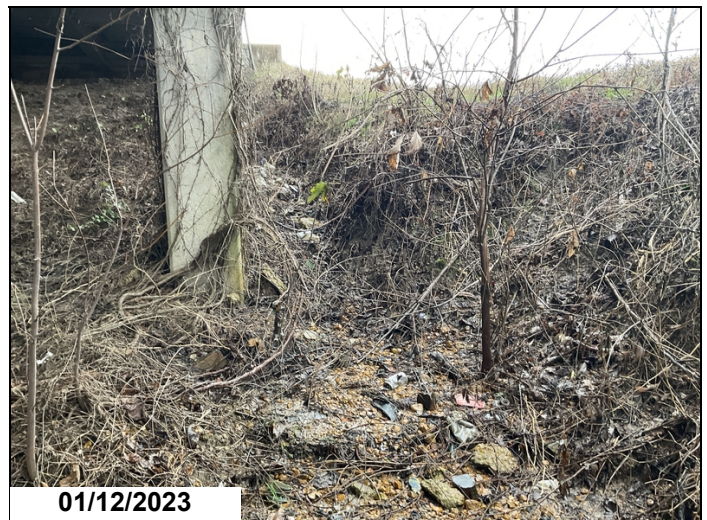
Spans #1 and 2 left slope eroded up to three feet beside bridge

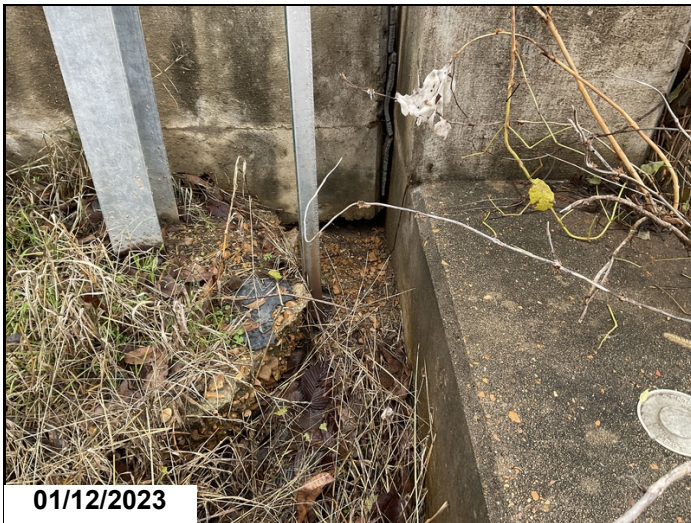
Abutment #1 right approach gutter has small void underneath at bridge end

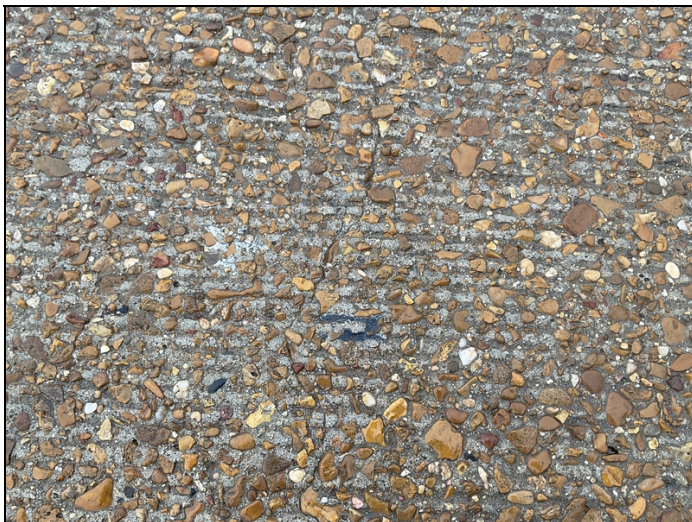
Deck each span has cs2 transverse and longitudinal cracks.

Typical longitudinal deck crack

A-54 - Sealable Deck Cracks (Yes)

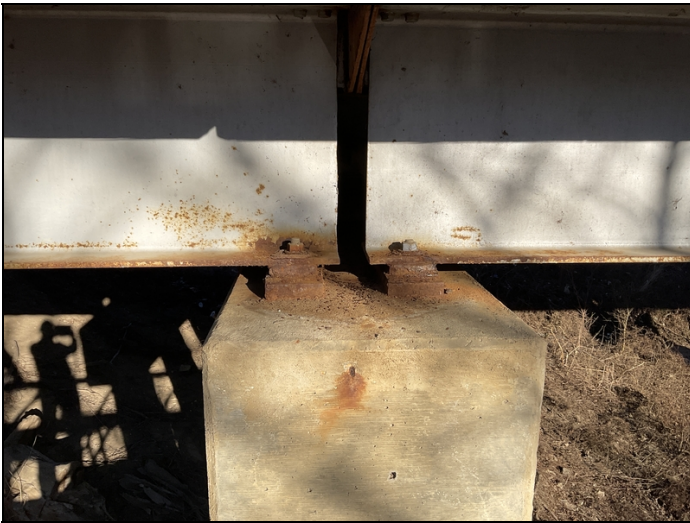
Bent #2 girder #6 bearings are corroded and span #1 and 2 girder #6 bottom flange outside has scaly rust

A-57 - Girder End and Bearing Painting Needed (Yes)

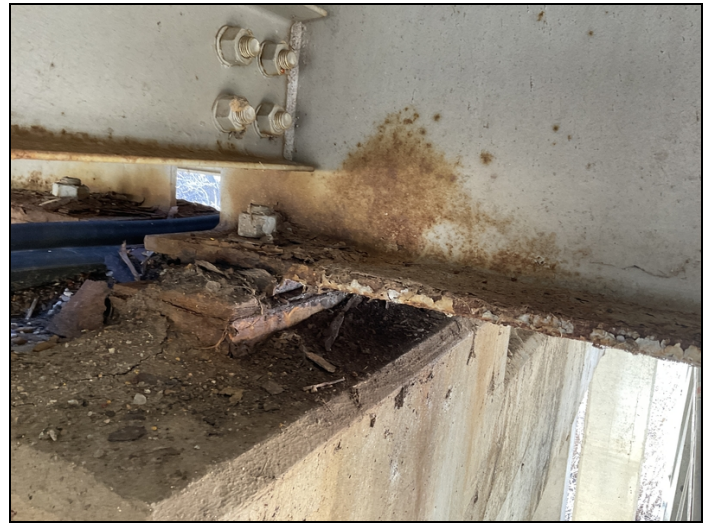
Corrosion on bearings and girder ends

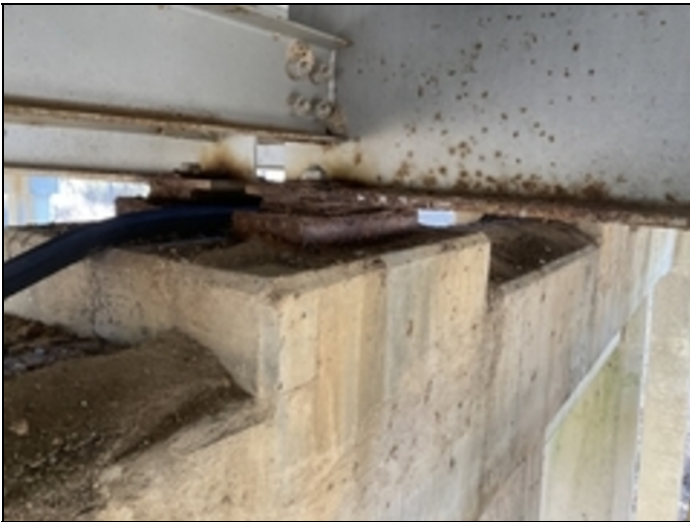
Corrosion on girder ends and bearings at bent #7

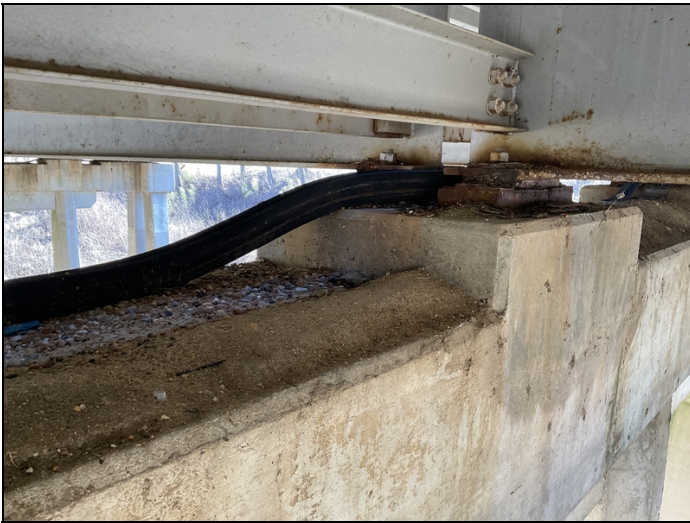
Bent #7 dirt and debris on caps

A-58 - Cap Cleaning/Flushing Needed (Yes)

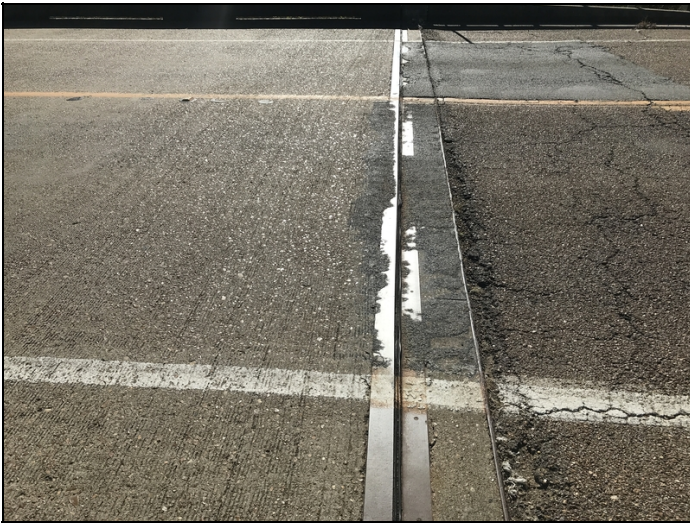
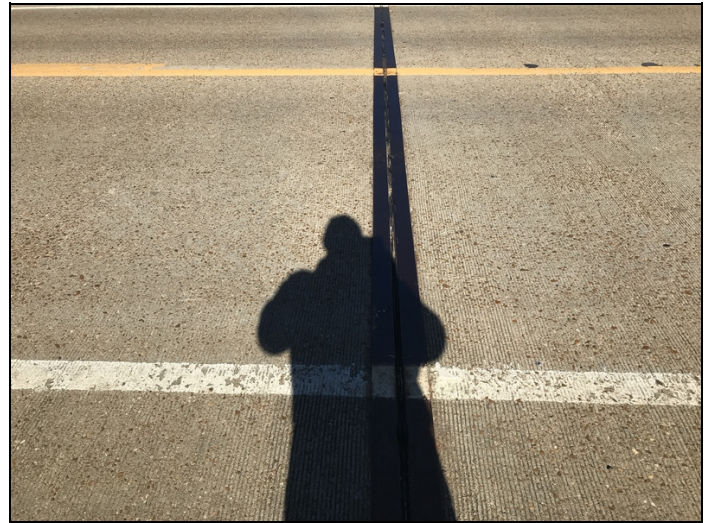
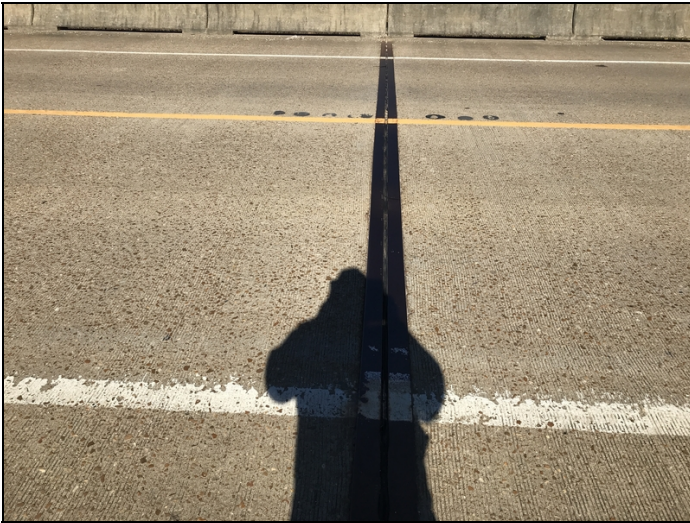
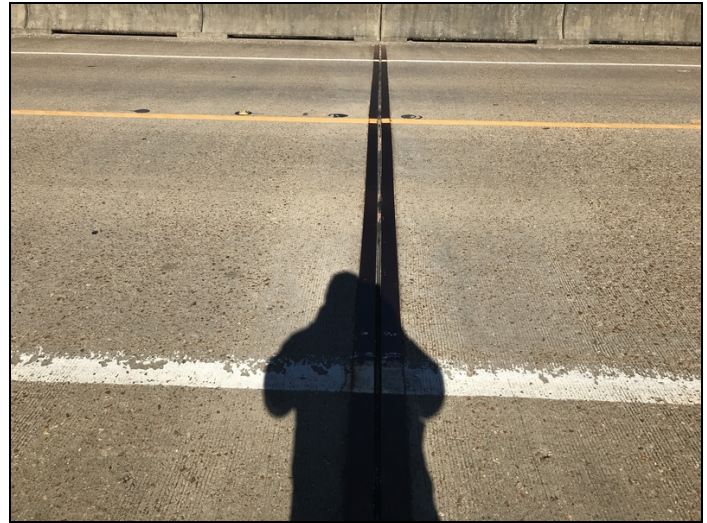
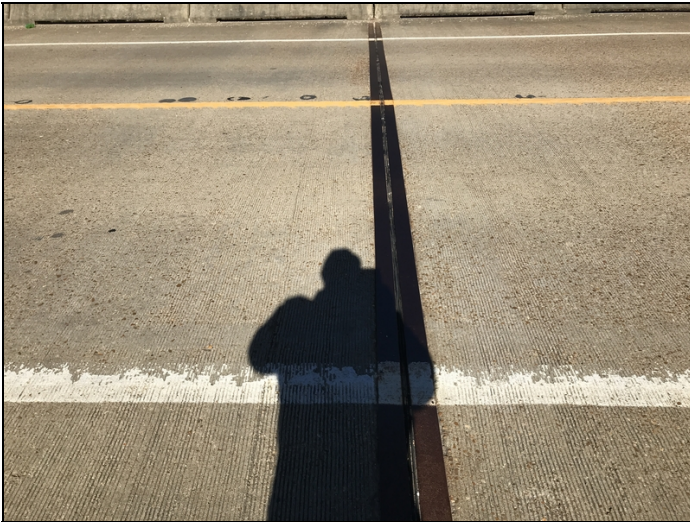
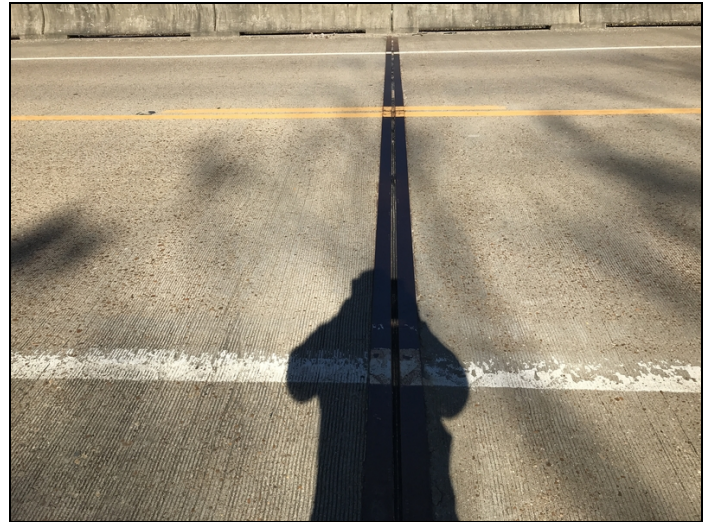
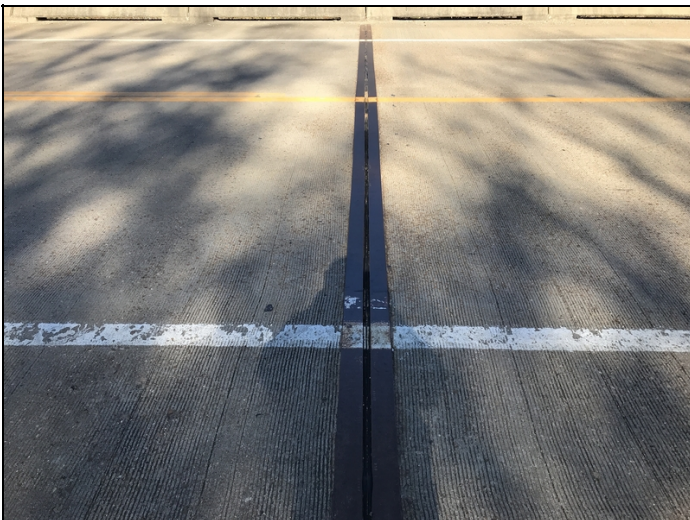
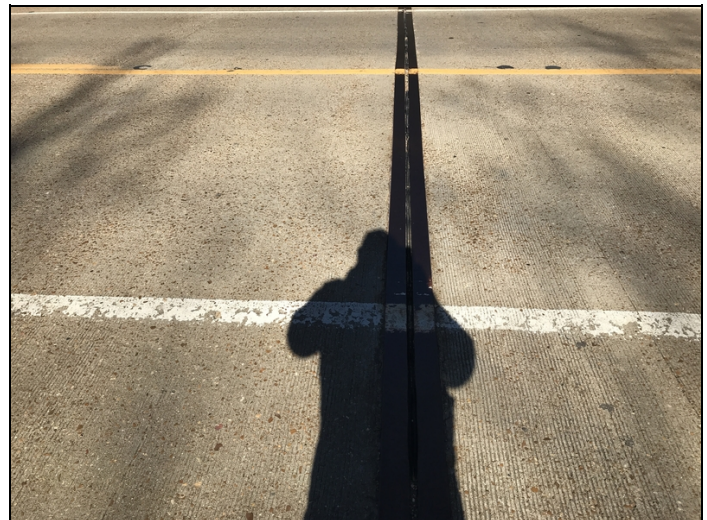
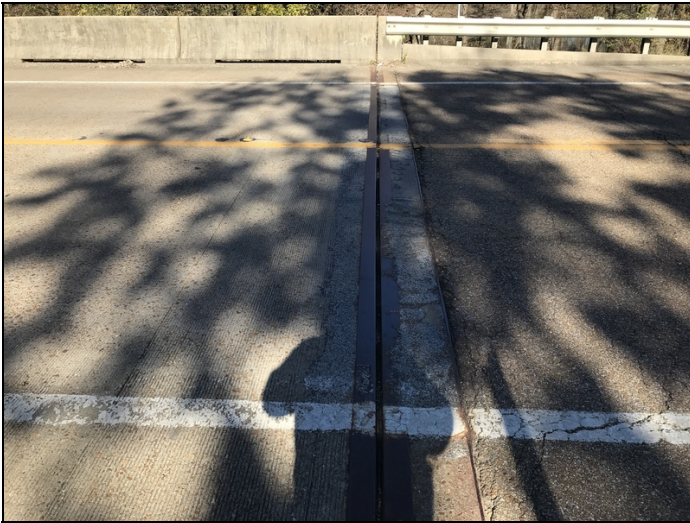
Compression joint seals are weathered and cracked.

A-59 - Joint Repair Needed (Yes)

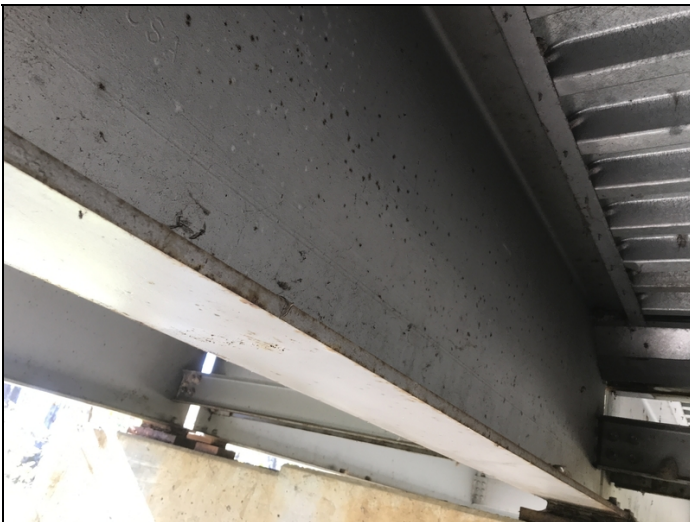
Steel girders have minor light rust spots showing through paint on web and bottom flange full length.

Typical girder paint condition

A-60 - Full Girder Painting Needed (Yes)

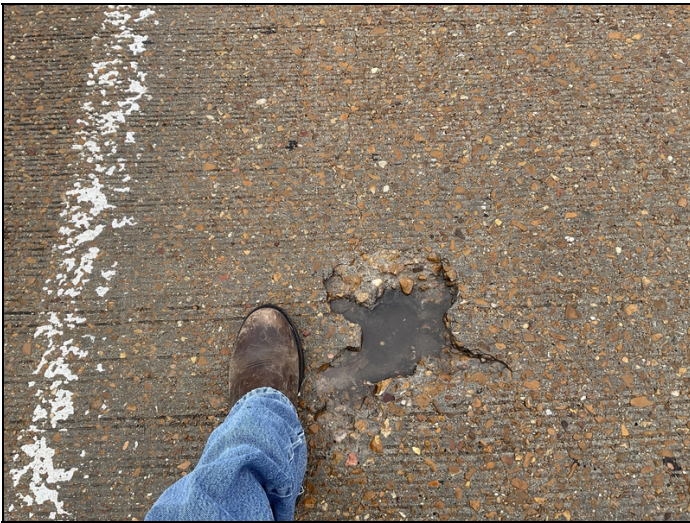
Span #5 deck left lane has one foot spall near mid span

A-61 - Polymer Overlay Advised (Yes)

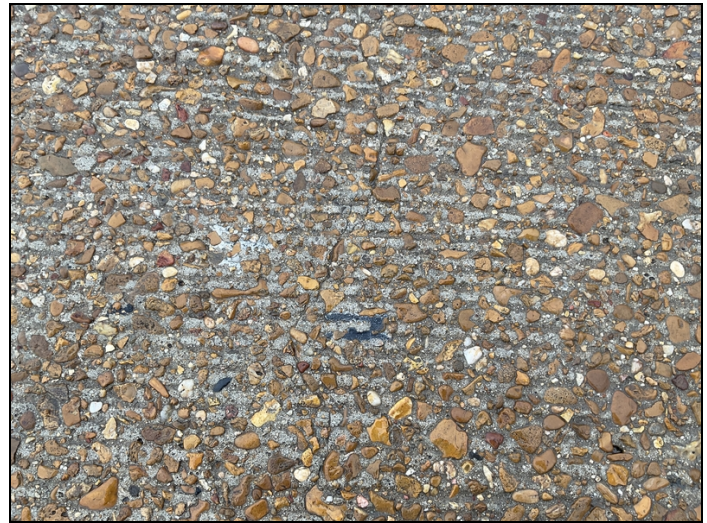
Deck each span has cs2 transverse and longitudinal cracks.

Typical longitudinal deck crack
