Asset #06048(Routine)

State Highway 162 over UNION PAC RR-Crawford Co

Location: 0.6 Mi E Jct US 64

Team Lead: Bob McEntyre Inspection Date: 09/18/2023

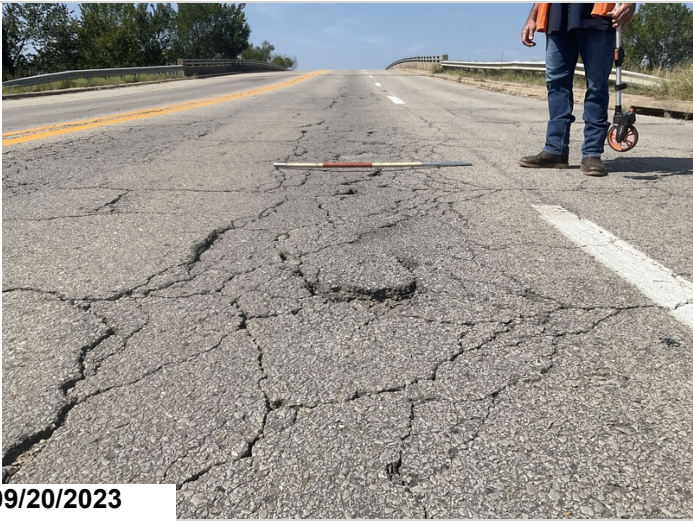
East approach roadway has rutting in the Eastbound lanes with potholes forming.

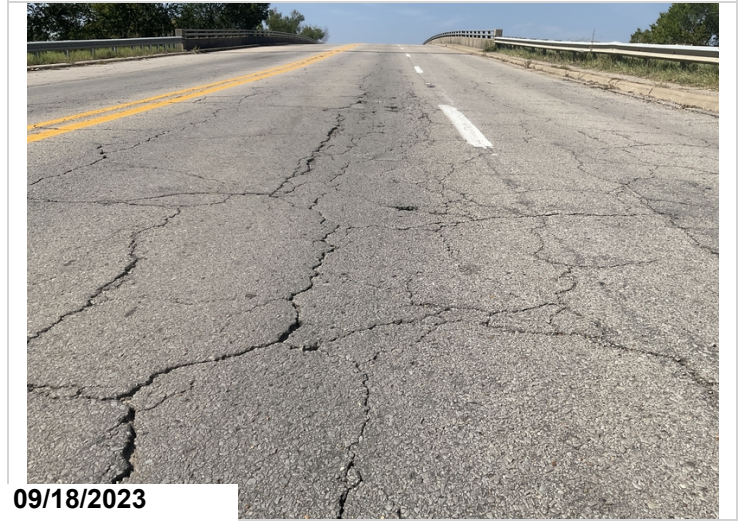
East approach roadway has rutting in the Eastbound lanes with potholes forming.

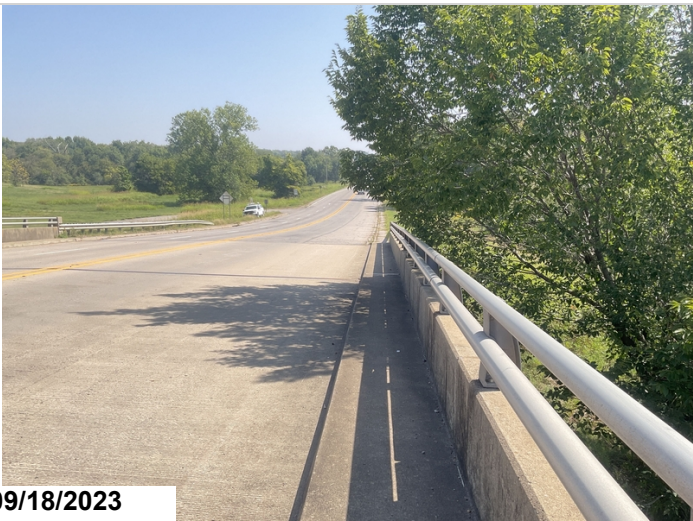
Vegetation is growing over right bridge railing and into driving lane at East bridge end.

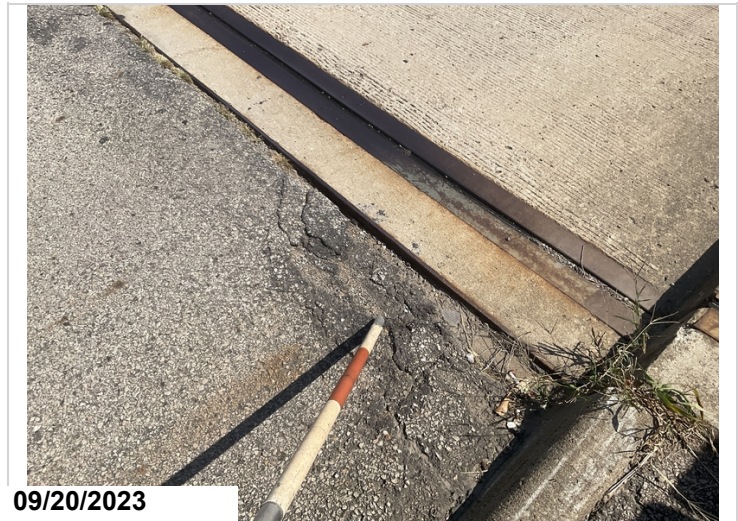
West approach roadway-Settlement with pothole forming in right outside lane

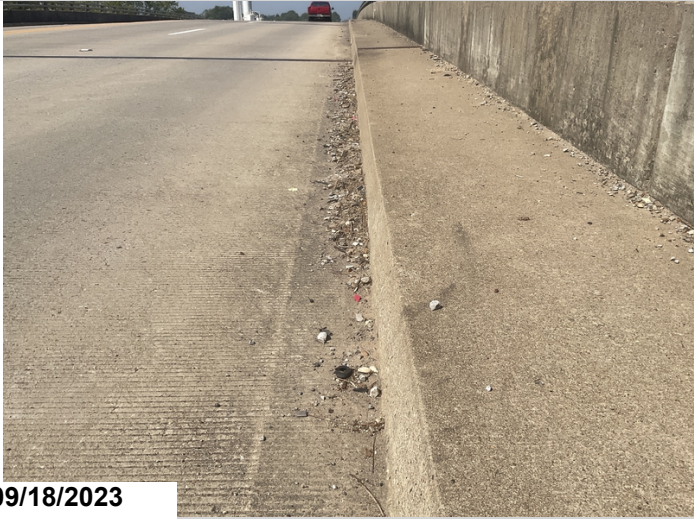
09/18/2023 - RSM & SPC: The gutters have dirt and debris accumulation.

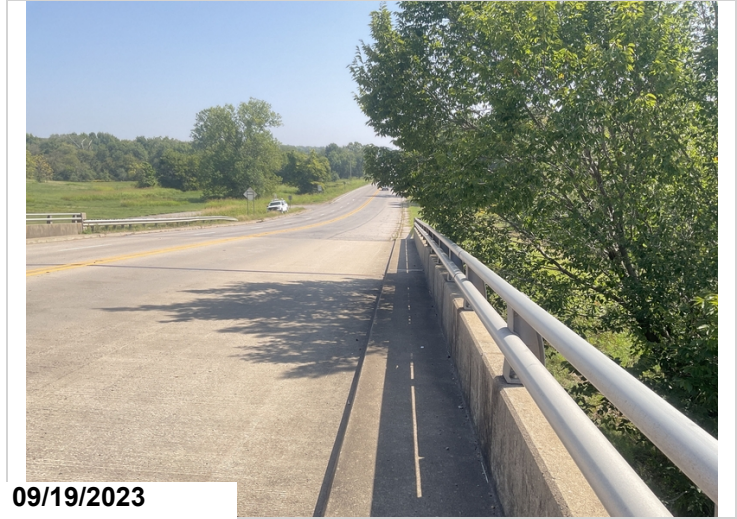
Vegetation is growing over right bridge railing and into driving lane at East bridge end.

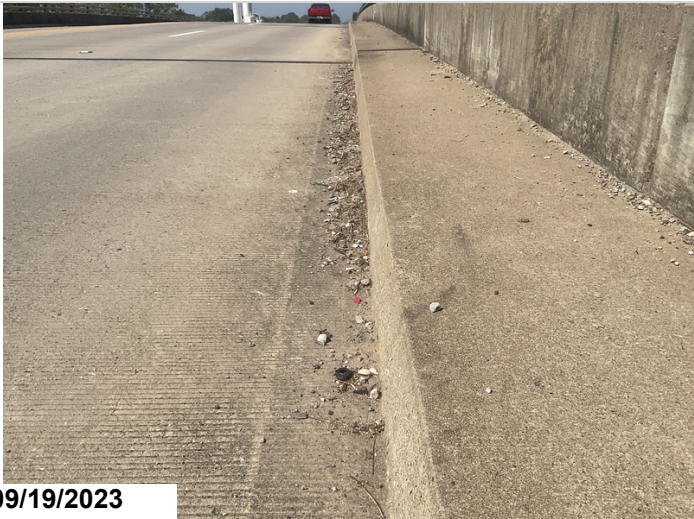
Dirt and debris in gutters

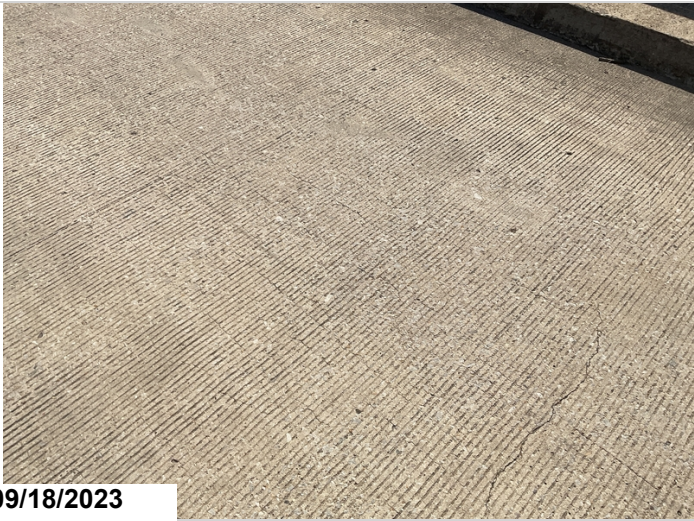
Span 5, right outside lane-Mapcracking in wheel path

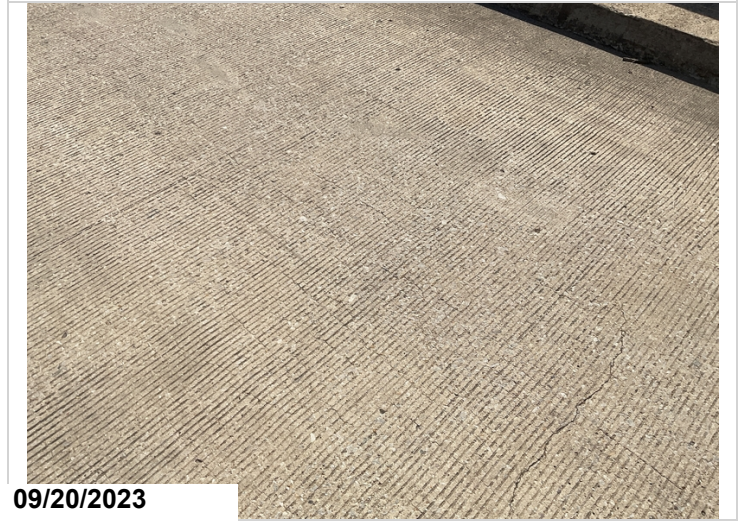
Span 5, right outside lane-Mapcracking in wheel path

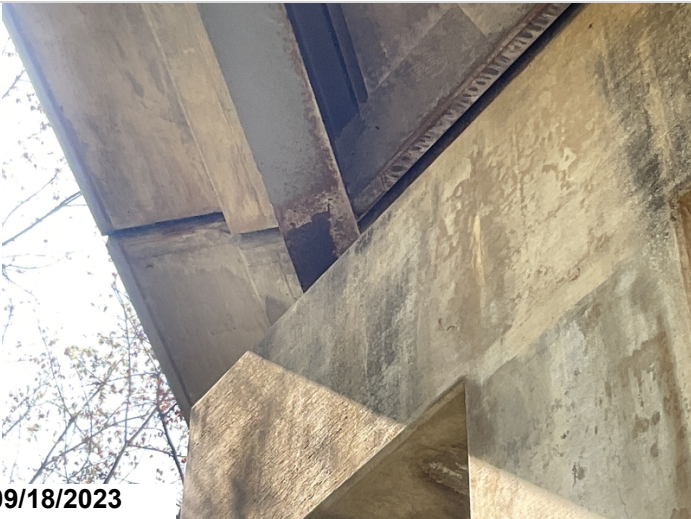
Bent # 5 beam # 7 corrosion

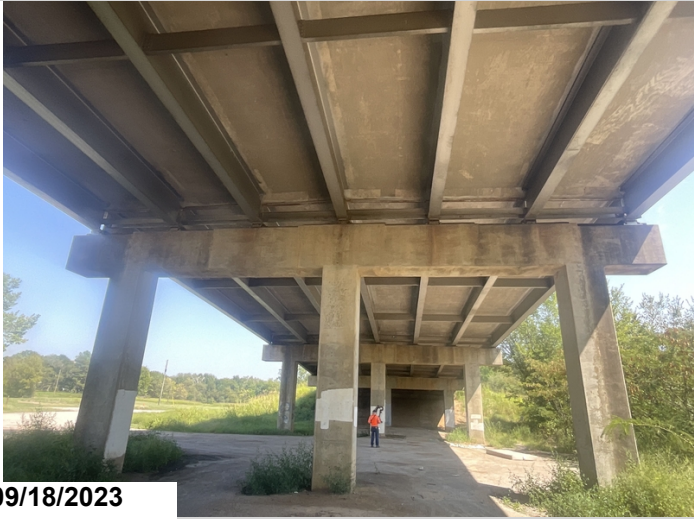
Bent # 6

09/18/2023 - RSM & SPC: Expansion joint seals are deteriorated and leak. The expansion joint seals at bents # 4 and 6 have fallen out of the assemblies.

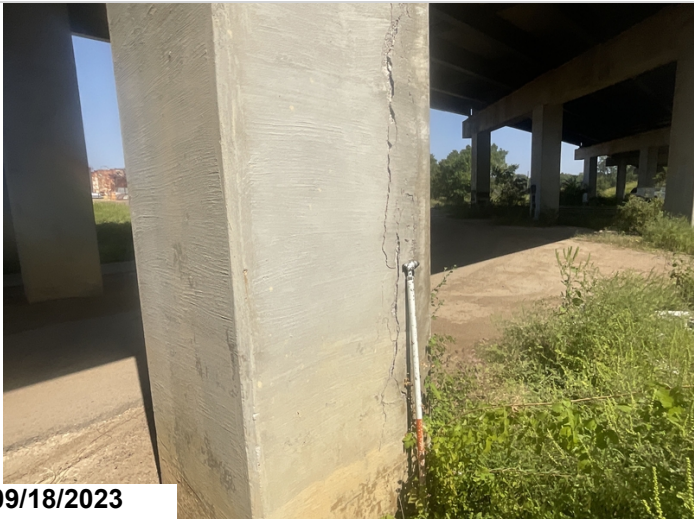
Bent # 3, column # 3 has an 8' high vertical delamination in the base.

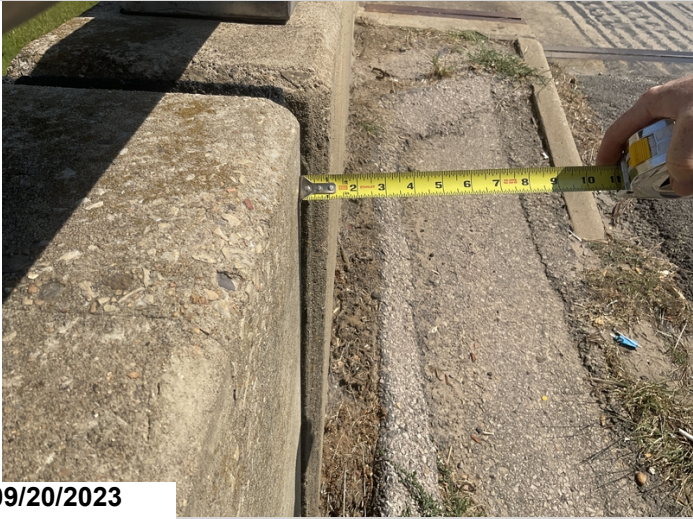
Abutment # 1 left retaining wall-Leaning away from roadway.

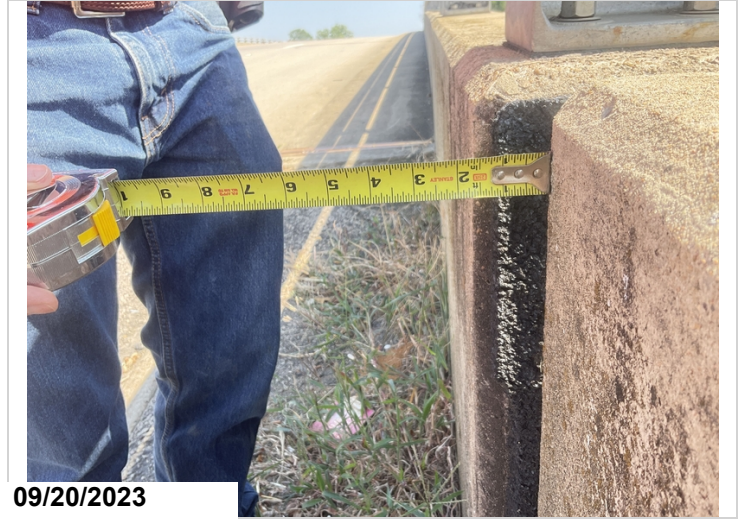
Abutment # 1 right retaining wall -Leaning away from roadway.

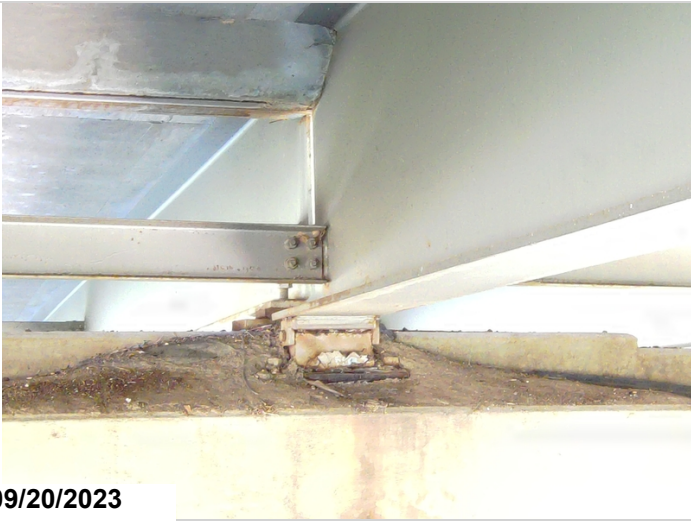
Drone Photo-Heavy dirt and debris accumulation on bent cap

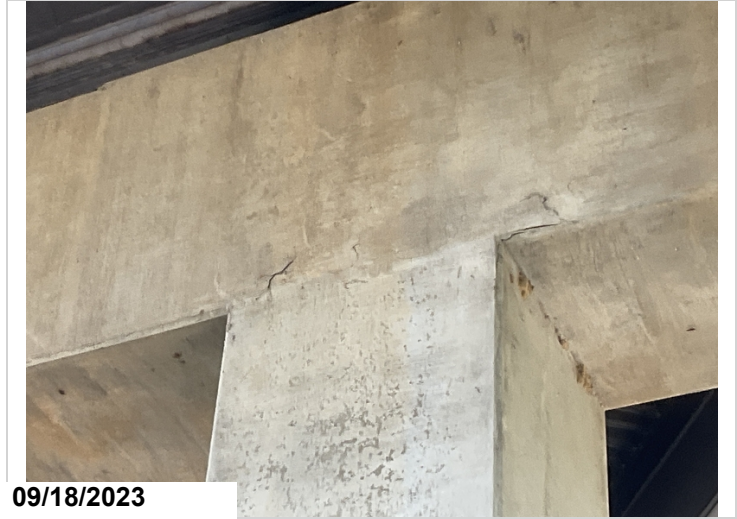
Bent # 4 has several delaminated areas in the back face of the cap.

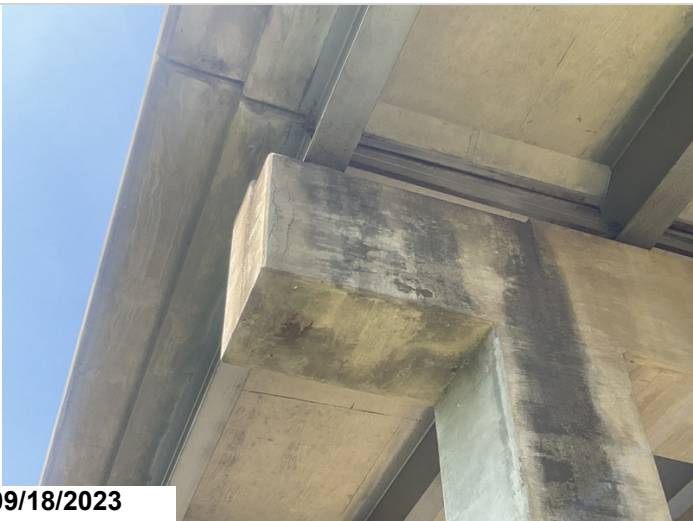
Bent # 3 has two, 2' tall delaminated areas in the right end of cap

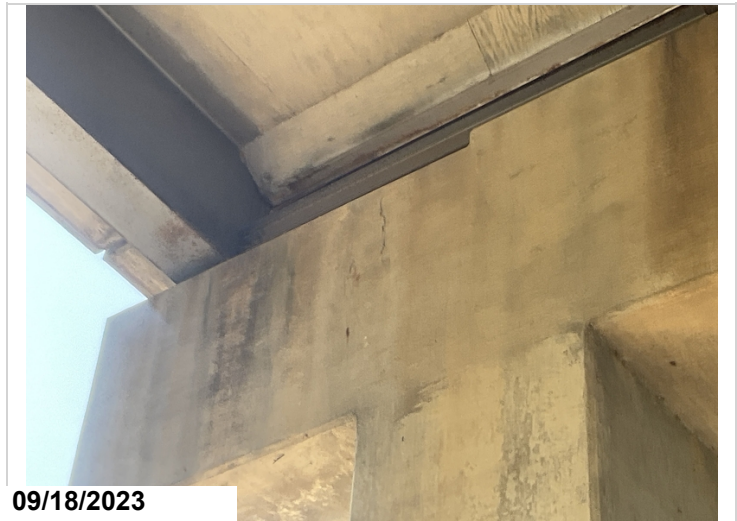
Bent # 2 cap has a few delaminated areas in both faces of the cap.

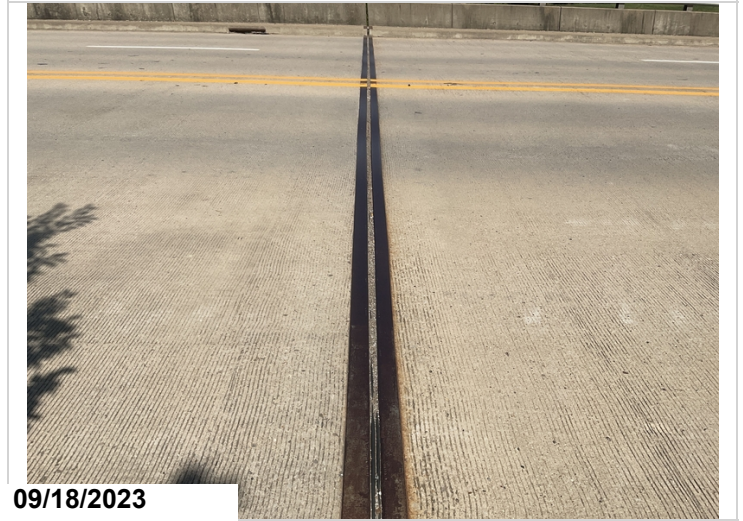
Bent 7 expansion joint

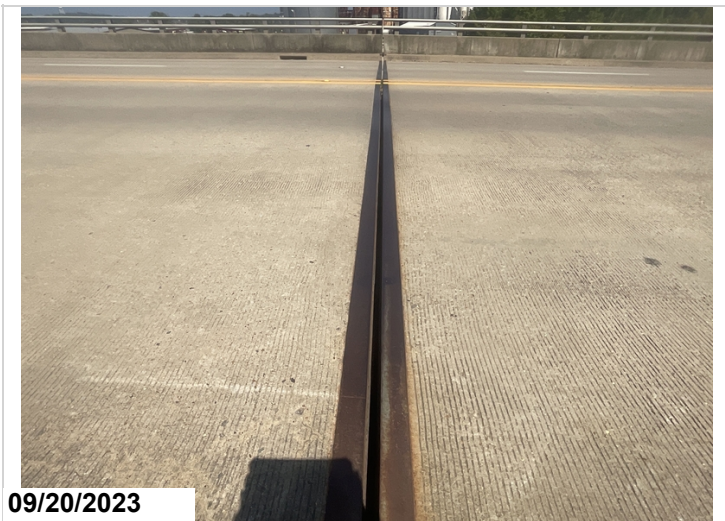
Bent 6 expansion joint seal fallen out of the assembly

The compression joint seals at bents # 4 and 6 have fallen out of position and are laying on the caps below. The open joints are allowing water, dirt, and debris to leak onto the substructure causing corrosion to the bearings. The remaining joint seals are deteriorated and appear to leak water in numerous locations.

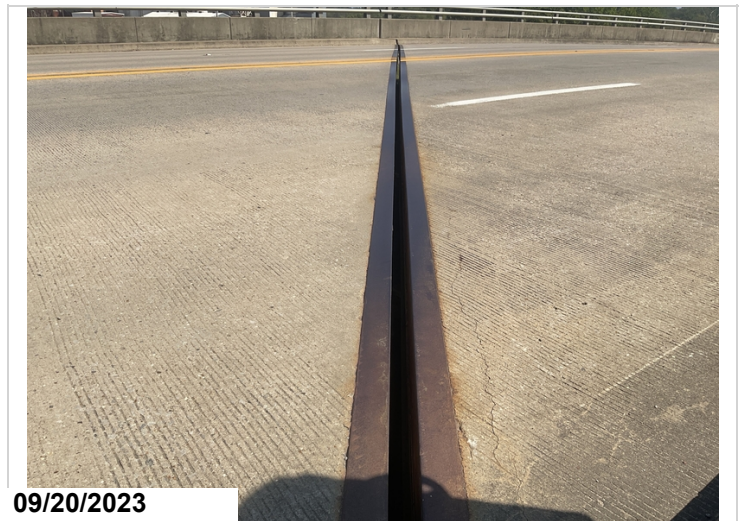
Bent # 4 expansion joint seal has fallen out of the assembly.

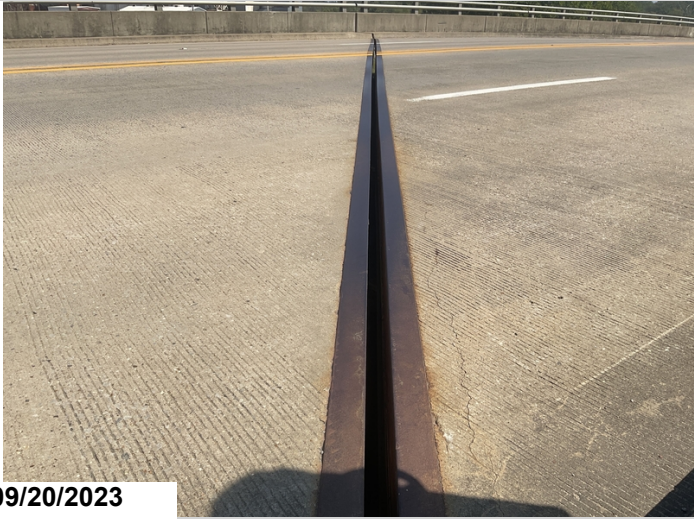
Bent 4 expansion joint seal fallen out of position

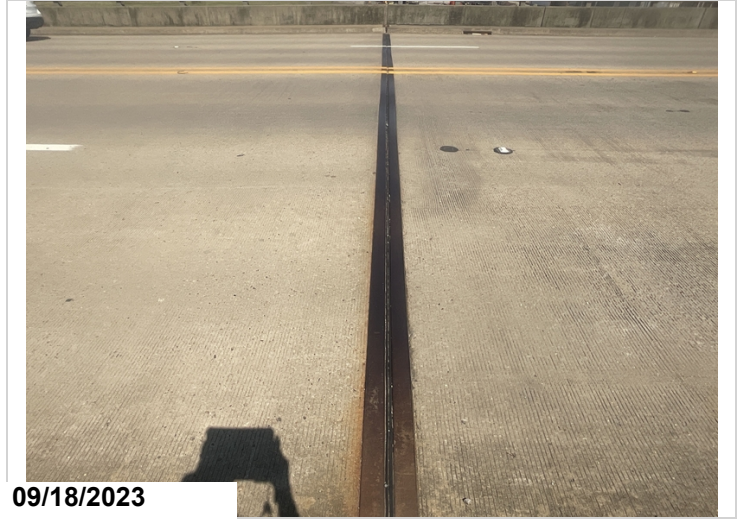
Bent 3 expansion joint

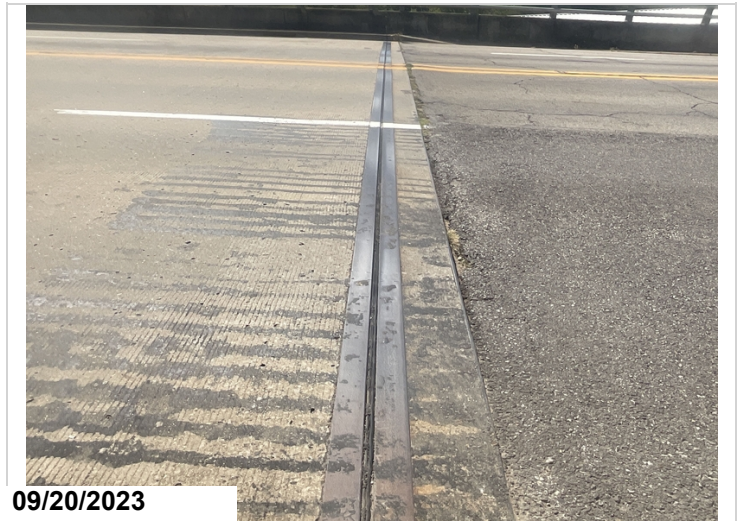
Abutment 1 expansion joint

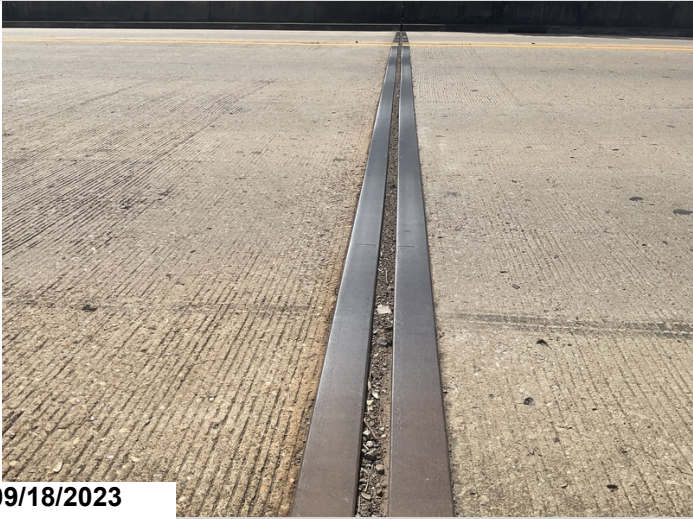
Dirt and debris in expansion joint

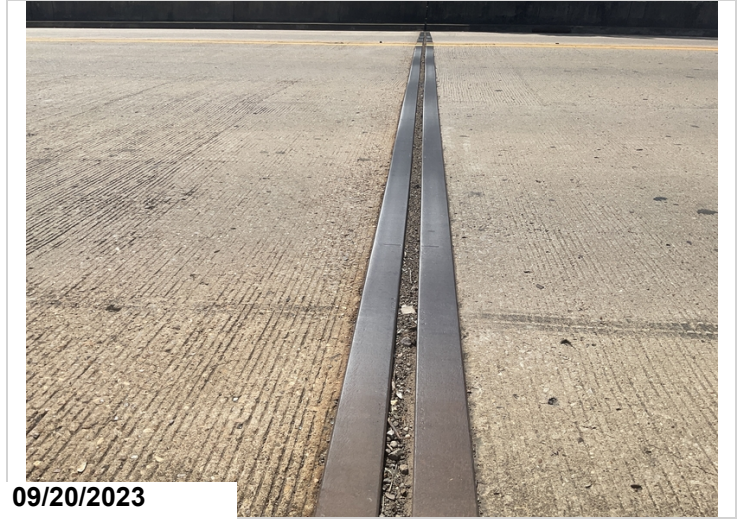
Dirt and debris in expansion joint

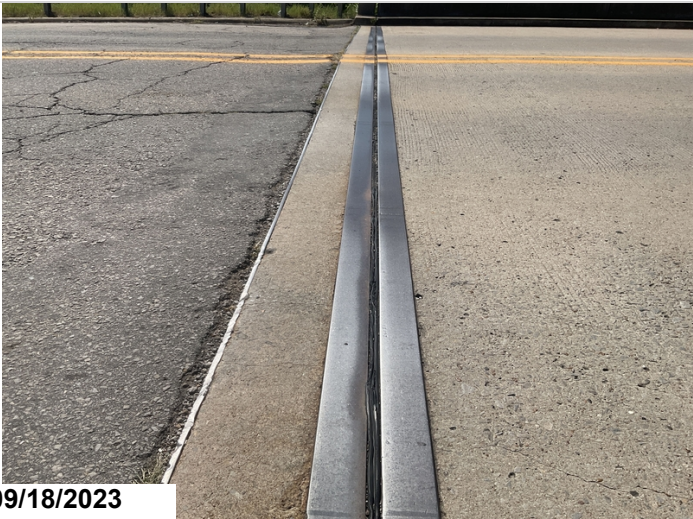
Abutment 2 expansion joint seal

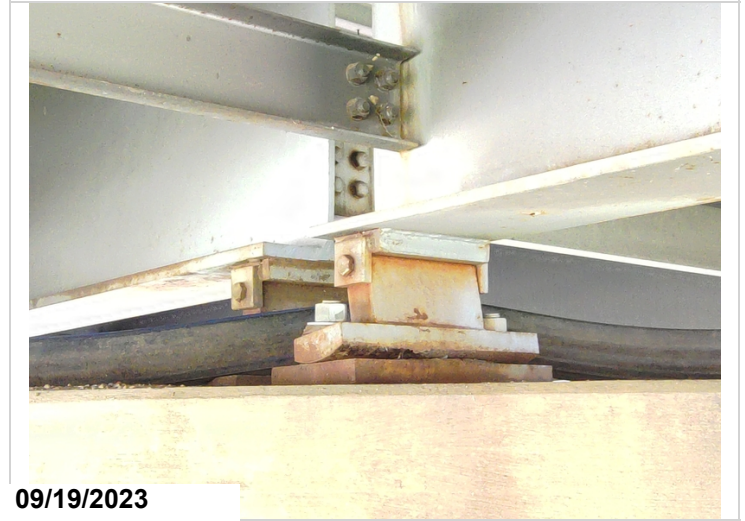
Drone Photo-General view of moveable bearing

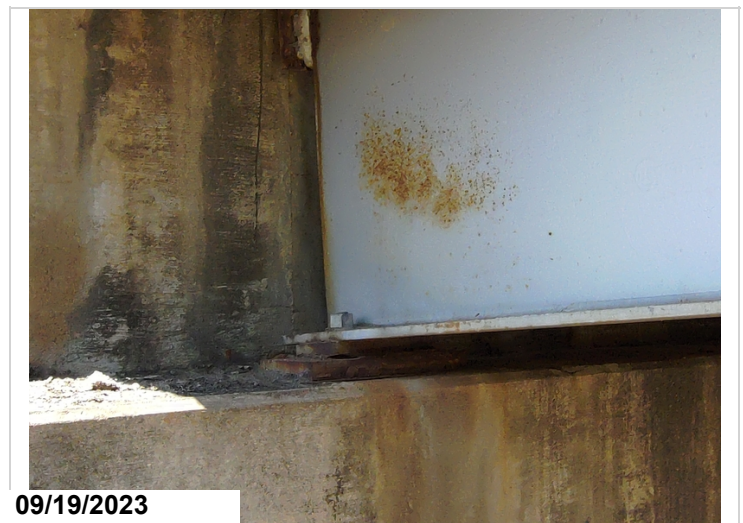
Drone Photo-Abutment # 1, bearing 7

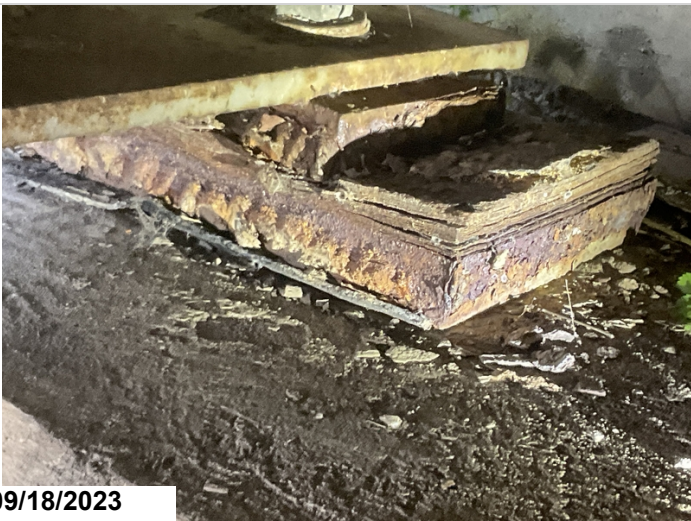
Abutment # 2 bearing # 1

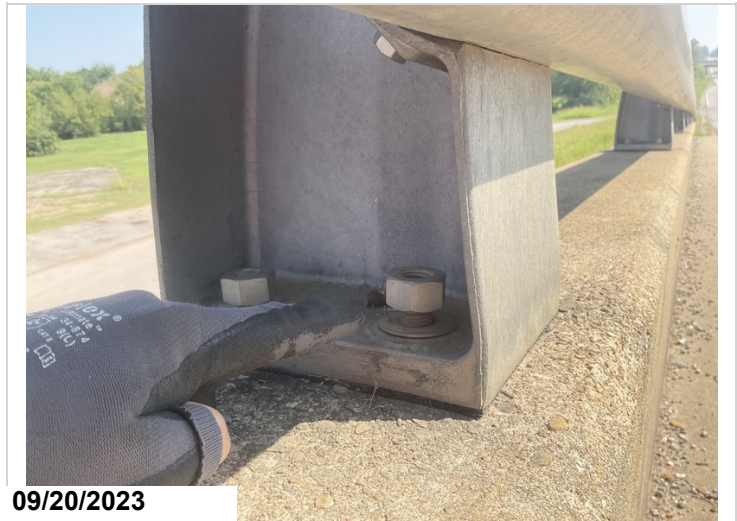
Loose anchor bolt nuts that attach metal railing posts to concrete railing

The metal bridge railing anchored to the top of concrete railing has numerous loose anchor bolt nuts in random locations.

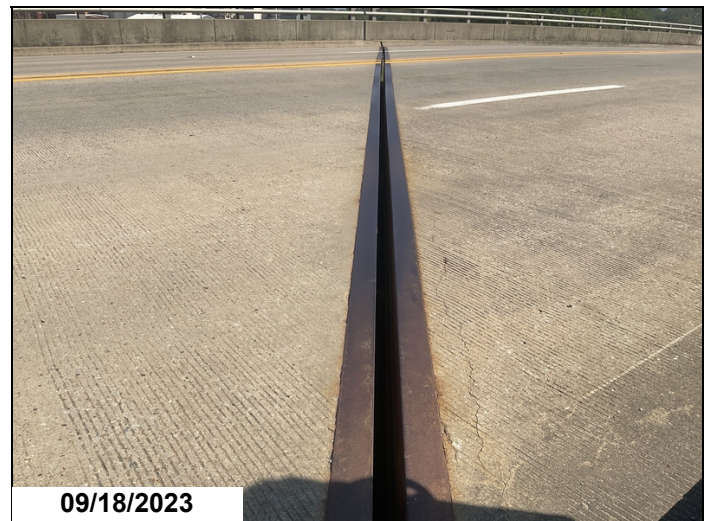
Bent # 4 expansion joint seal has fallen out of the assembly.

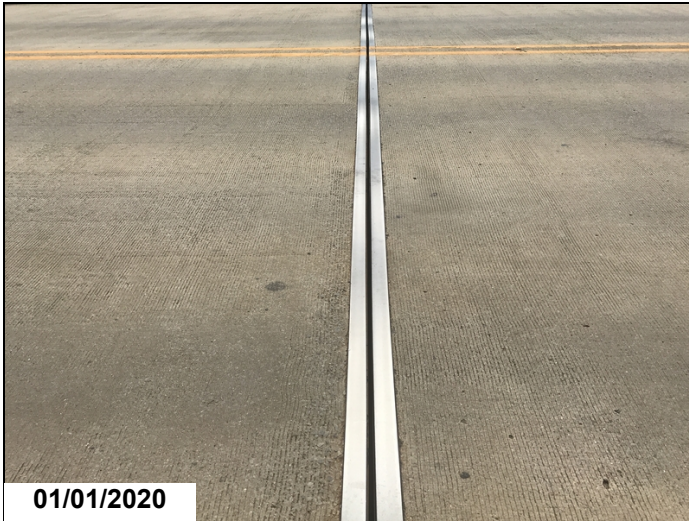
Bent # 6-Joint seal has fallen out of the assembly.

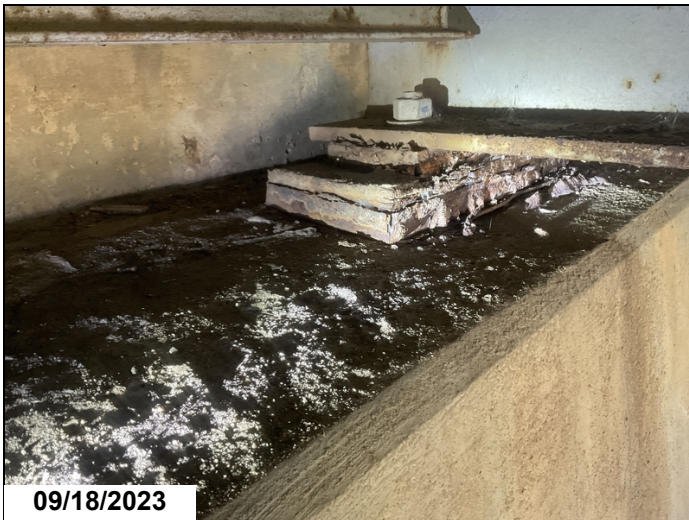
Bearings have a failing paint system with numerous areas of active corrosion, layers of flaking rust, and minor section loss between the sole plates and masonry plates.

Abutment # 2 bearing # 3-Corrosion.

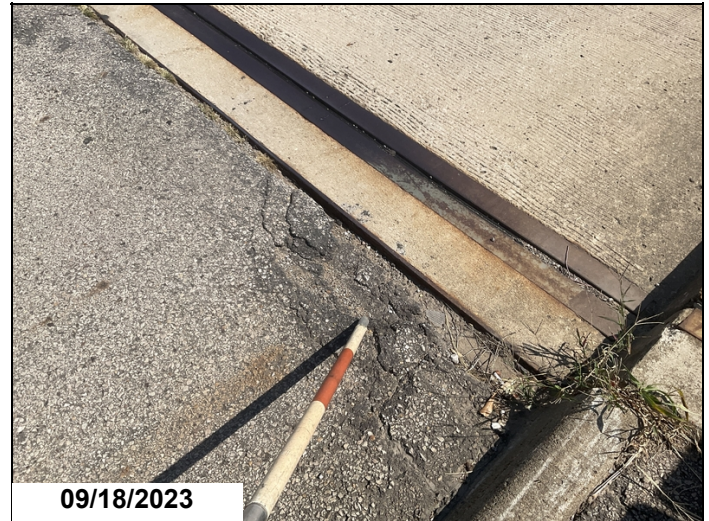
The asphalt at the approaches has settlement and is deteriorating with potholes forming in the driving surface. The East approach has heavy rutting in the wheel paths.

West approach roadway-Settlement with pothole forming in right outside lane.

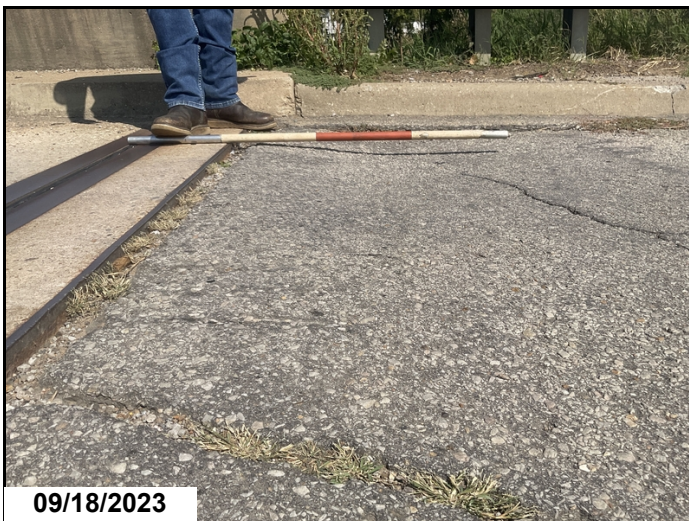
East approach Roadway-Settlement at bridge end.

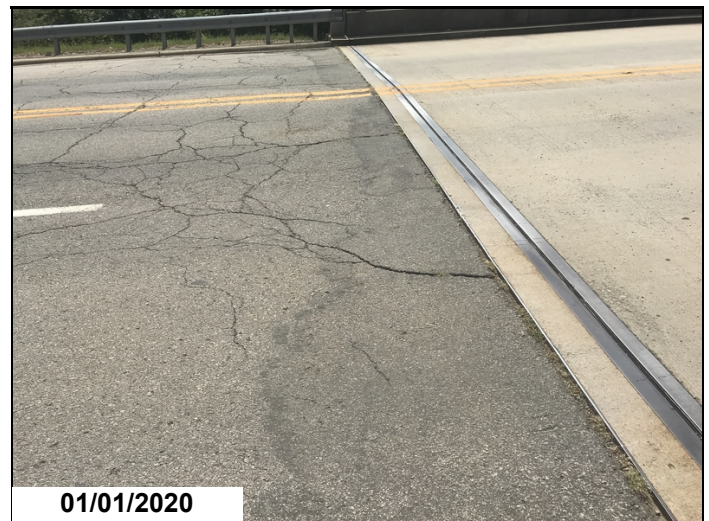
East approach roadway-Settlement.

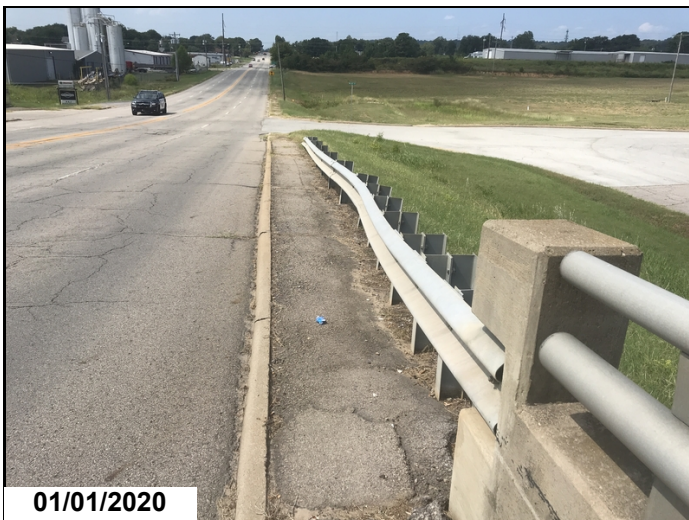
Approach Guardrailing -
Minor collision damage to the left approach guardrailing at both bridge ends.

Abutment # 1 left approach railing-Collision damage.

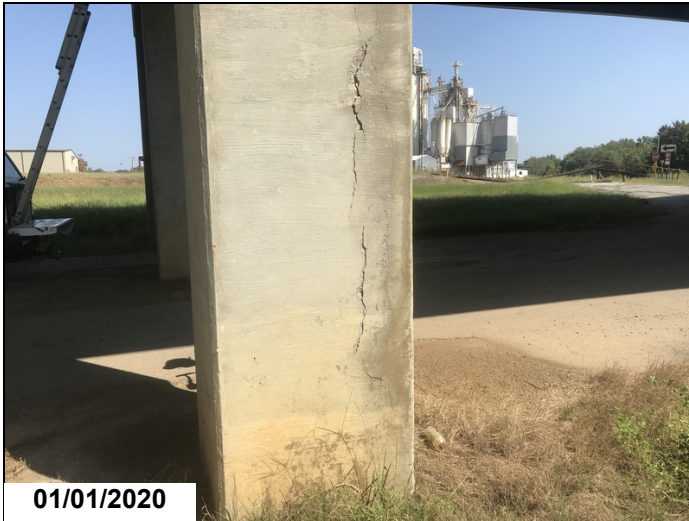
The substructure has delaminated areas and spalls that expose reinforcing steel in several locations.

Bent # 3, column # 3-Delaminated area.

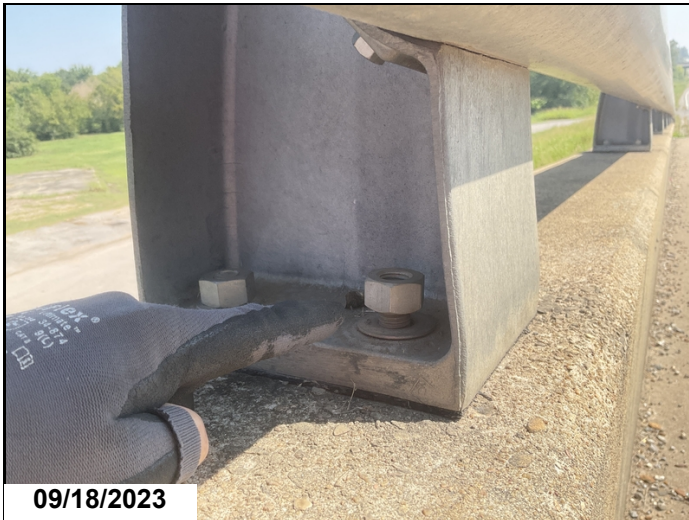
Loose anchor bolt nuts that attach metal railing posts to concrete railing.

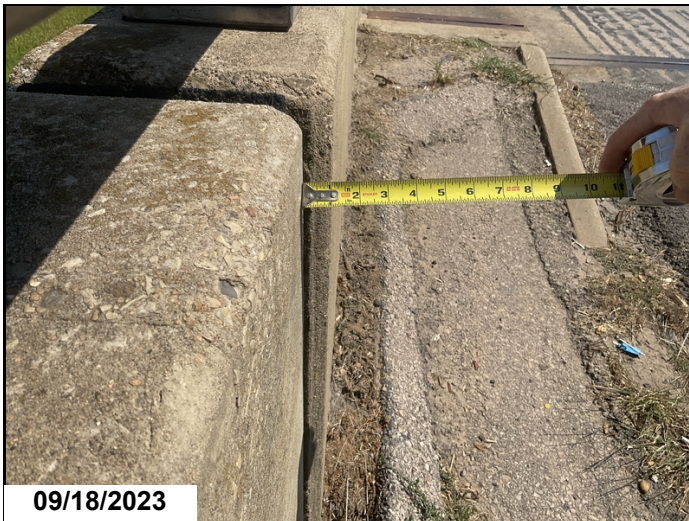
The retaining wing walls at abutment # 1 (West Abutment) appear to be leaning away from the roadway. The left wall is misaligned 7/8" during this inspection. The right wall is misaligned 1-3/8". Measurements were taken approximately 9' from the centerline of the expansion joint on top of the fill at the construction joint in the retaining wall.

Abutment # 1 left retaining wall-Leaning away from roadway.

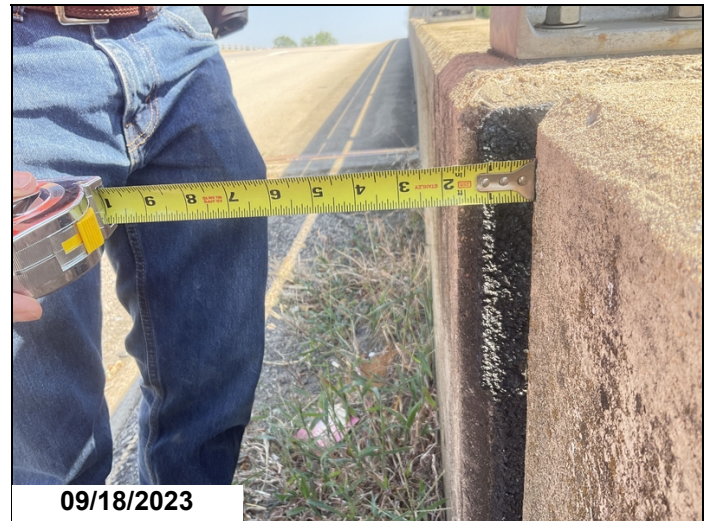
Abutment # 1 right retaining wall -Leaning away from roadway.

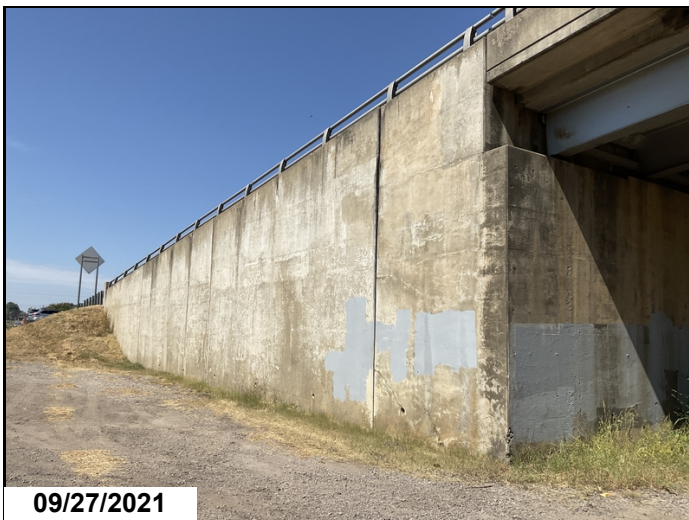
Abutment # 1 right retaining wall leaning away from roadway.

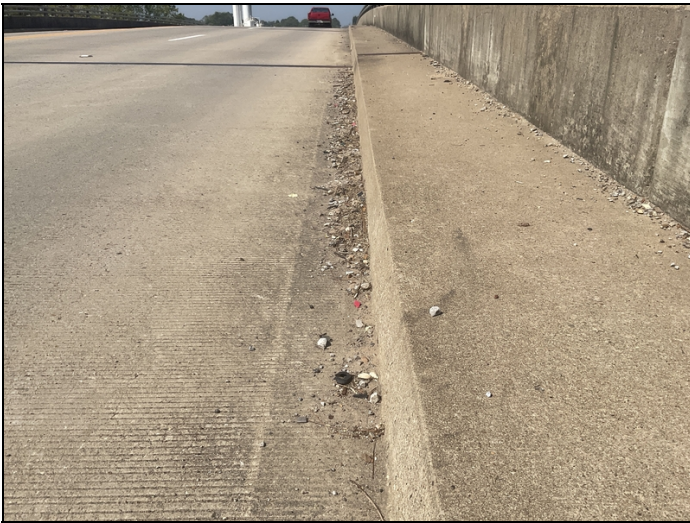
09/18/2023 - RSM & SPC: The gutters have dirt and debris accumulation.

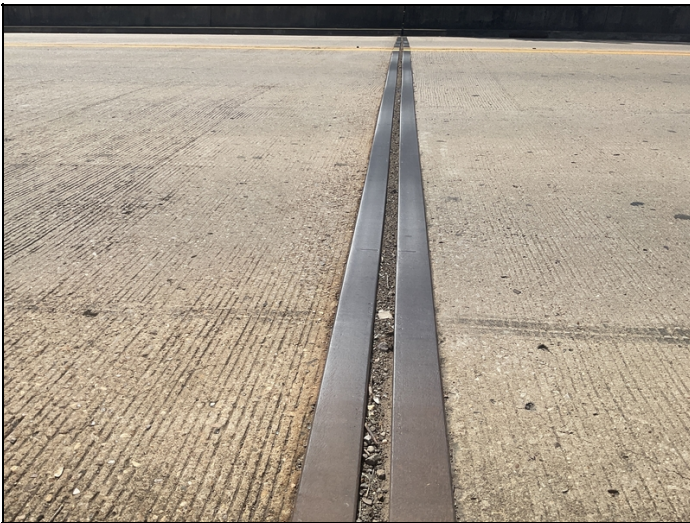
09/18/2023 - RSM & SPC: The expansion joint assemblies have dirt and debris accumulation.

Dirt and debris in expansion joint

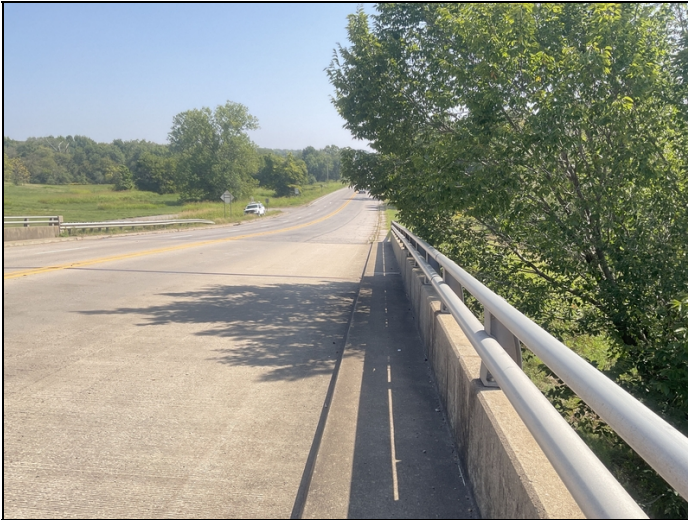
09/18/2023 - RSM & SPC: Vegetation is growing over right bridge railing and into driving lane at East bridge end.

Vegetation is growing over right bridge railing and into driving lane at East bridge end.
