Route:162 Section:01 Log:0.95

**Asset #03960**(Routine, Underwater type 2)  
**State Highway 162 over Flat RockCk-Crawford Co.**  
**Location: 0.95 MI E JCT US 64 & 162**  
**Team Lead: Bob McEntyre Inspection Date: 09/18/2023**

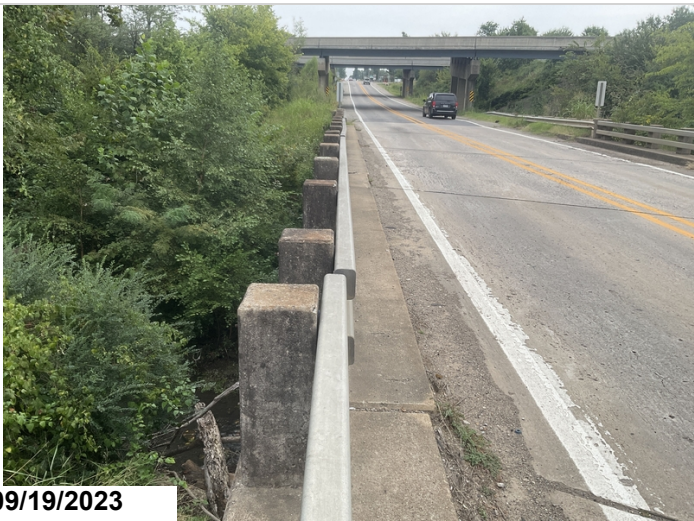
Misalignment of spans

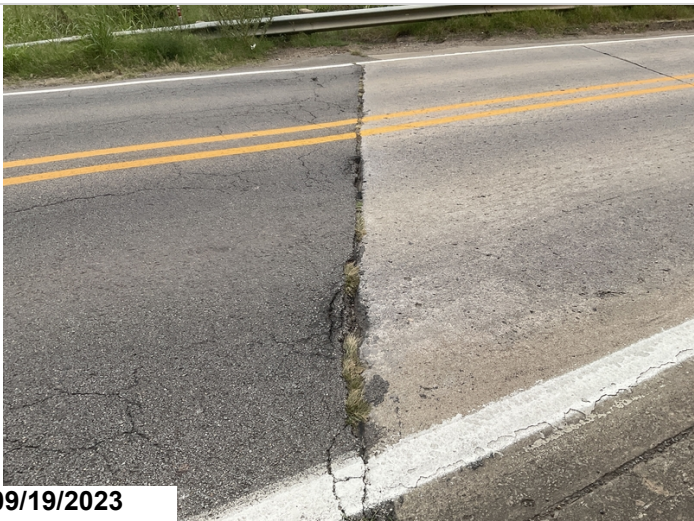
West approach roadway-Potholes forming at bridge end

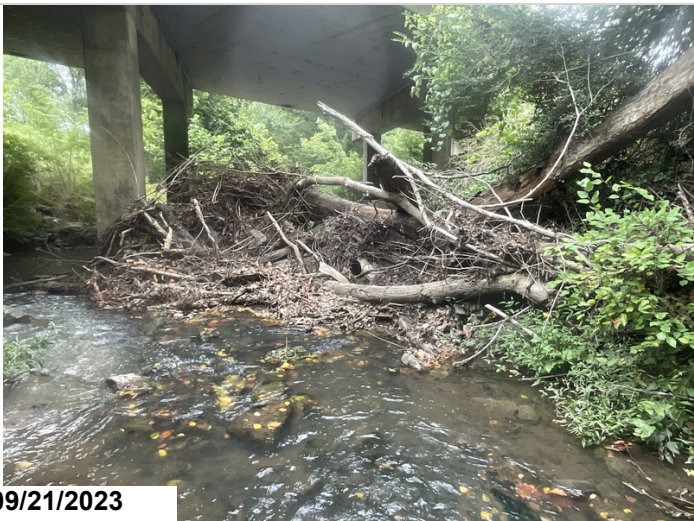
09/19/2023 - RSM & SPC: Underwater Type II Inspection. Wading, probing and visual observation in low water conditions revealed that all footings with no detectable undermining at this inspection. The Channel has heavy drift accumulation/ large trees at bent # 2 causing localized scour at the base of column # 1 and embankment erosion to the base of the East embankment.

Heavy drift accumulation at bent 2

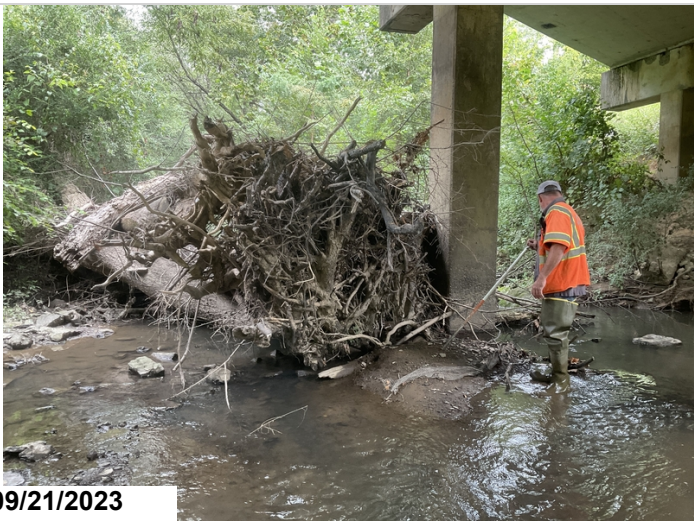
Channel has heavy drift accumulation/ large trees at bent #  
2.

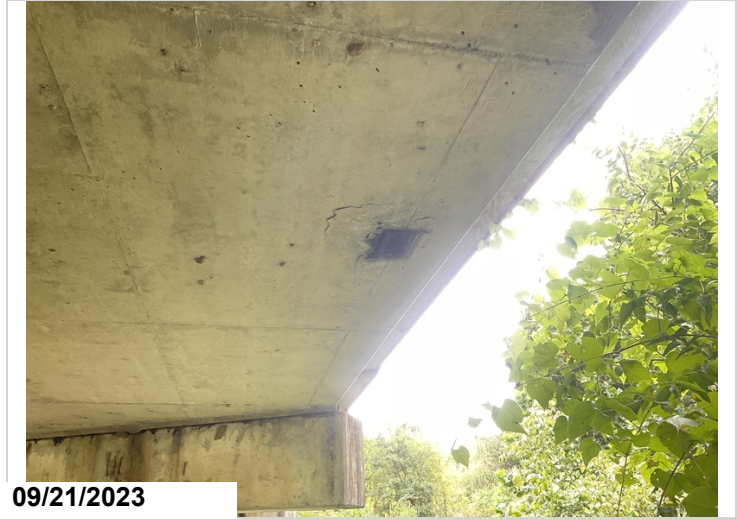
09/19/2023 - RSM & SPC: The Slab is in fair condition. The undersurface of the slab has areas with light scale/leaching. The undersurface has spalls with exposed reinforcing steel adjacent to the intermediate bent caps and delaminated areas adjacent to the deck drains.

Span 2 undersurface on right side-Delaminated area  
adjacent to deck drain

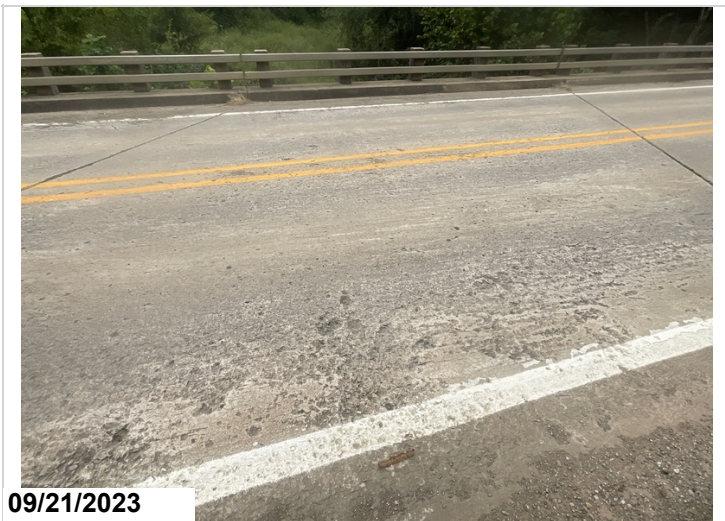
09/19/2023 - RSM & SPC: The Slab is in fair condition. The driving surface of the slab has numerous areas of medium / heavy scaling along the gutters up to approximately 2" deep in locations. Diagonal cracking in the corners of some of the spans. The cracking in some locations is wide.

Span 4 driving surface-Scaling

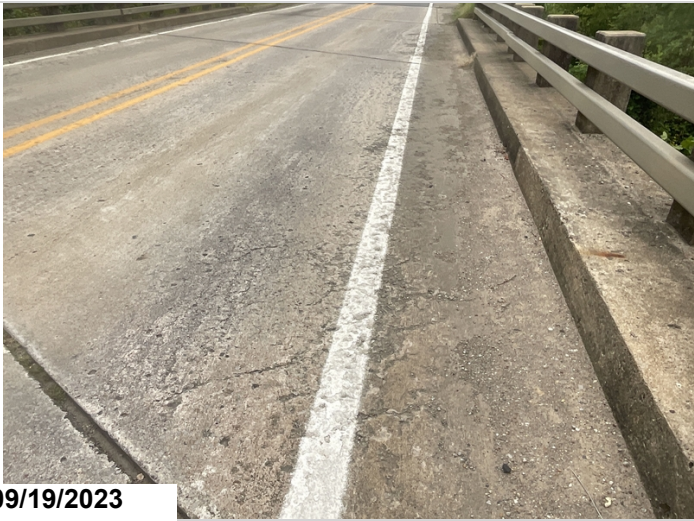
Span 4, right lane-Scaling

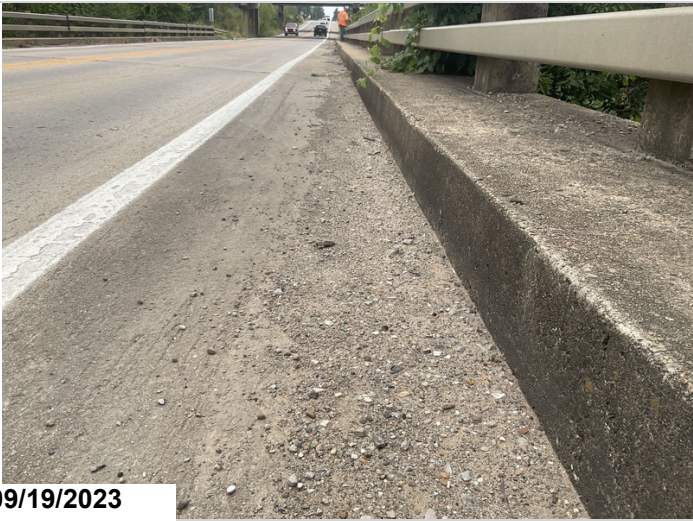
Dirt and debris in gutters

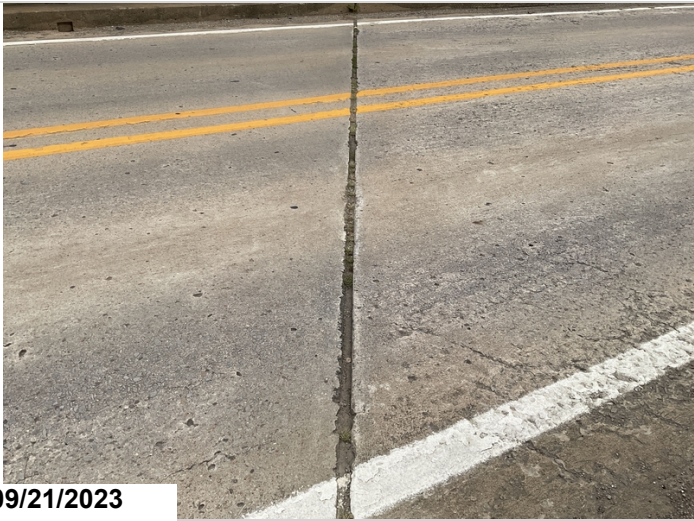
Bent 4 expansion joint

09/19/2023 - RSM & SPC: Slab expansion joint sealant is deteriorated/ missing with incompressible material in the joints.

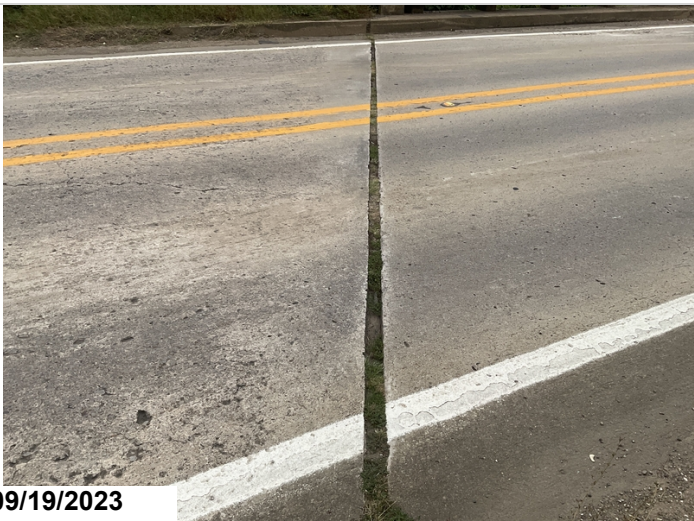
Abutment 1 expansion joint-Debris impaction

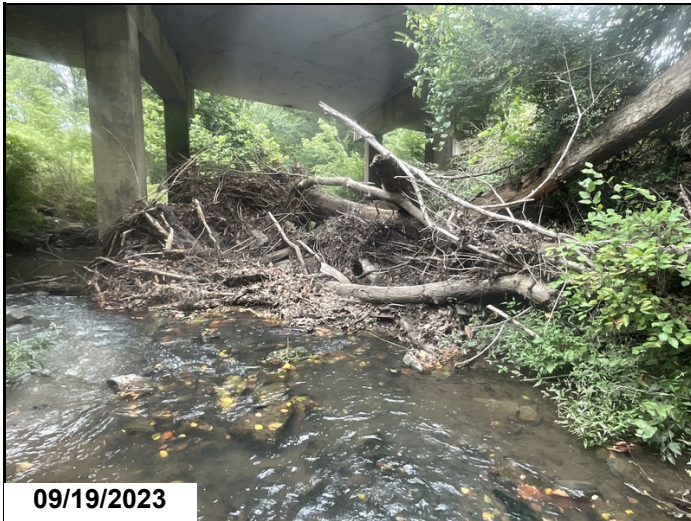
The Channel has heavy drift accumulation/ large trees at bent # 2 causing localized scour at the base of column # 1 and embankment erosion to the base of the East embankment.

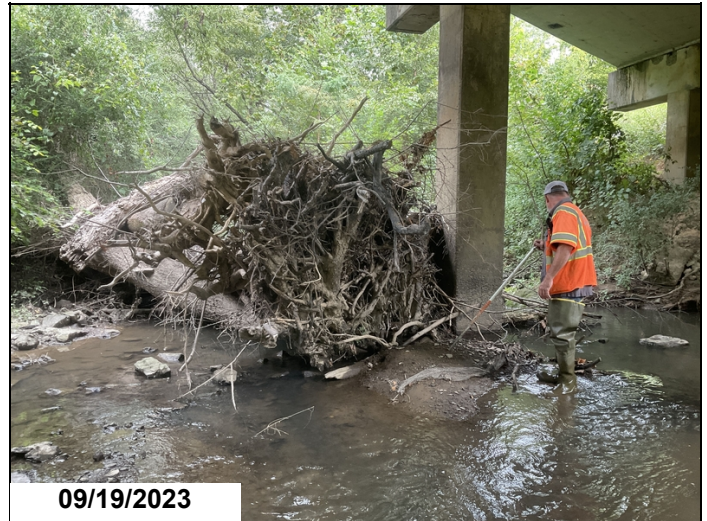
The Channel has heavy drift accumulation/ large trees at bent # 2 causing localized scour at the base of column # 1 and embankment erosion to the base of the East embankment.

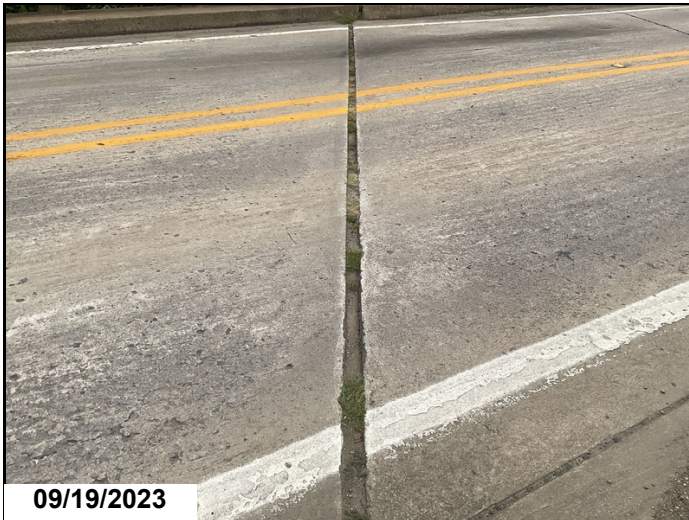
09/19/2023  
Abutment # 2 expansion joint-Debris impaction.

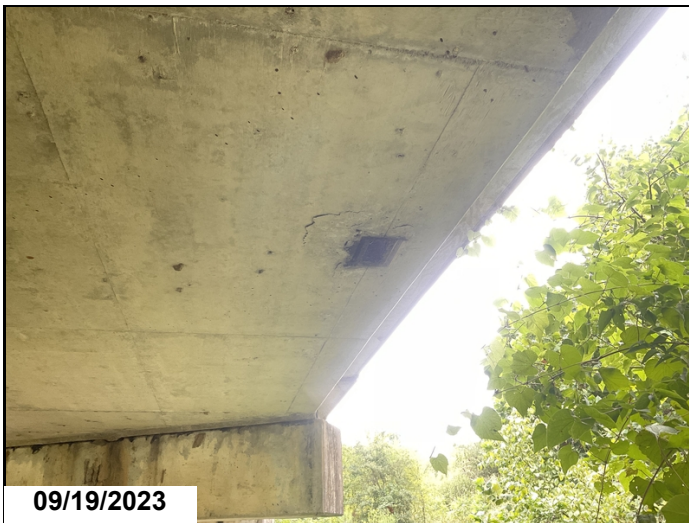
Span # 2 undersurface on right side-Delaminated area adjacent to deck drain.

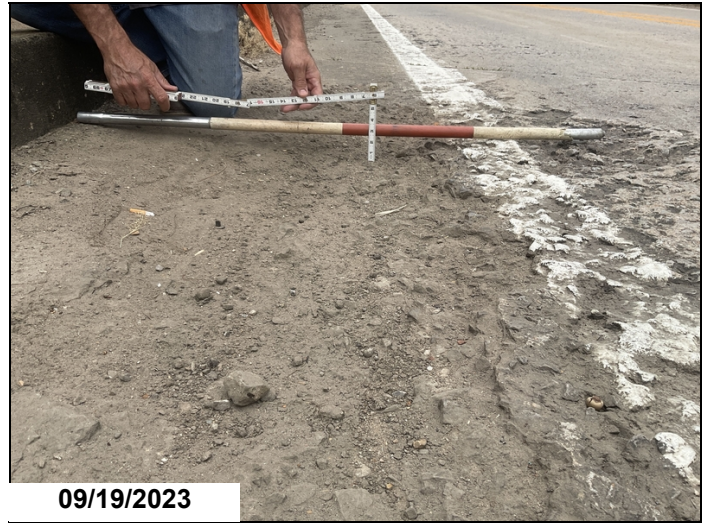
Span # 5, right shoulder has heavy scaling up to approximately 2" deep.

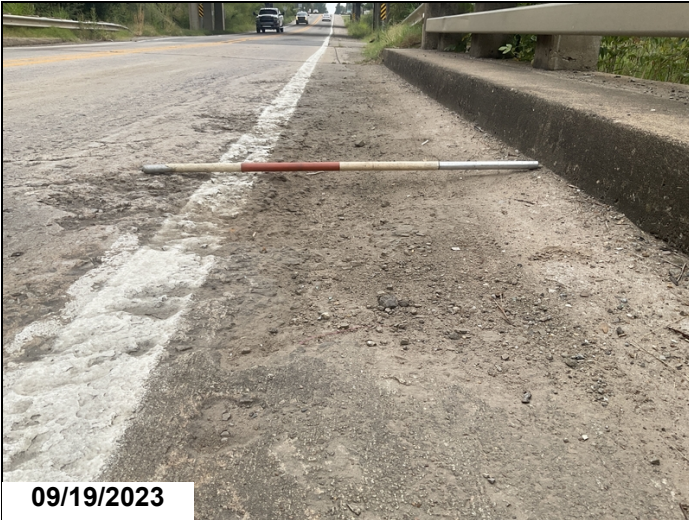
Span # 5, right shoulder has heavy scaling up to approximately 2" deep.

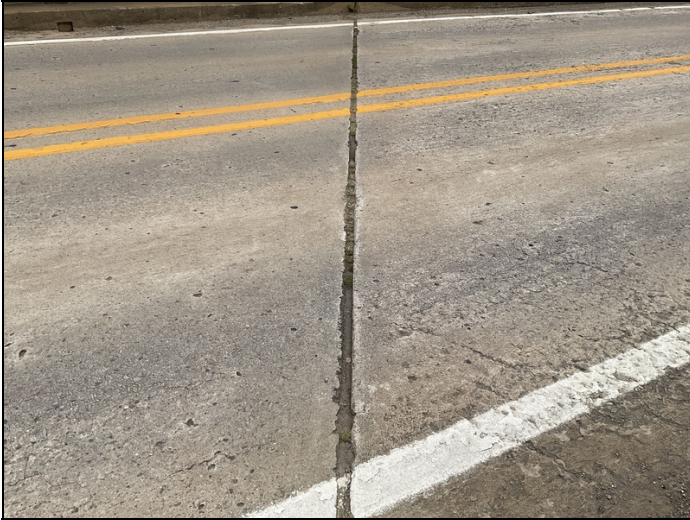
Bent 4 expansion joint

09/19/2023 - RSM & SPC: Slab expansion joint sealant is deteriorated/ missing with incompressible material in the joints.

**A-56 - Joint Cleaning/Flushing Needed (Yes)**

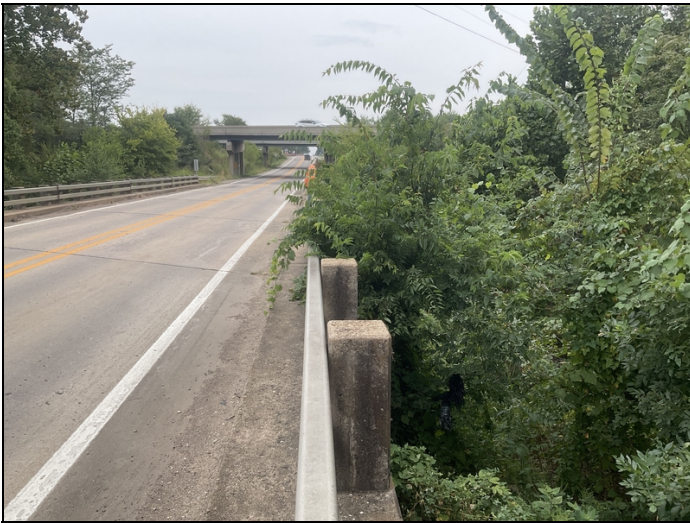
09/19/2023 - RSM & SPC: Vegetation is growing over the right bridge railing and into the driving lane.

Vegetation growing over right bridge railing.

**A-64 - Vegetation Removal Requested (Yes)**
